# *Animas Museum Master Plan*

LA PLATA COUNTY HISTORICAL SOCIETY  
FINAL MASTER PLAN  
SHF 24-PL-014  
OCTOBER 9, 2024

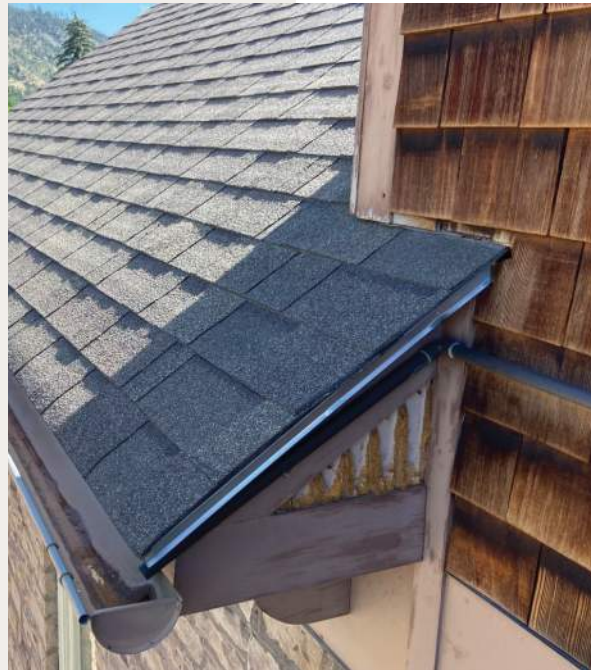
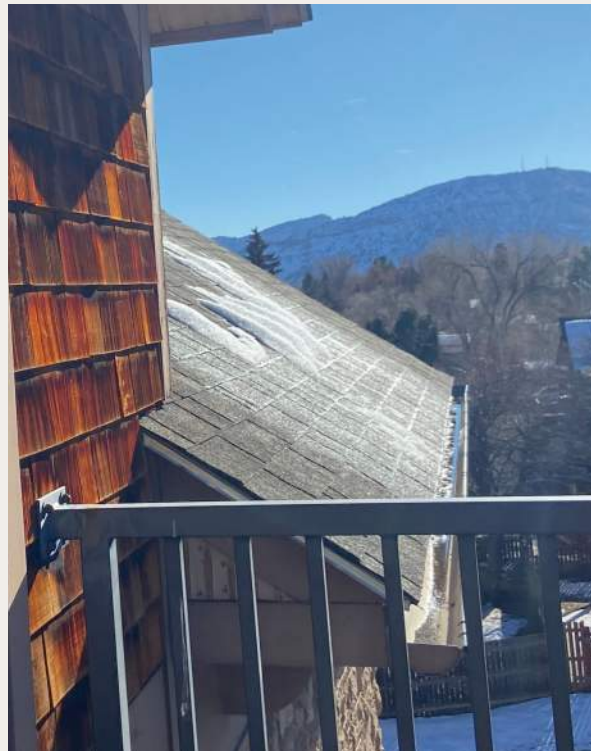
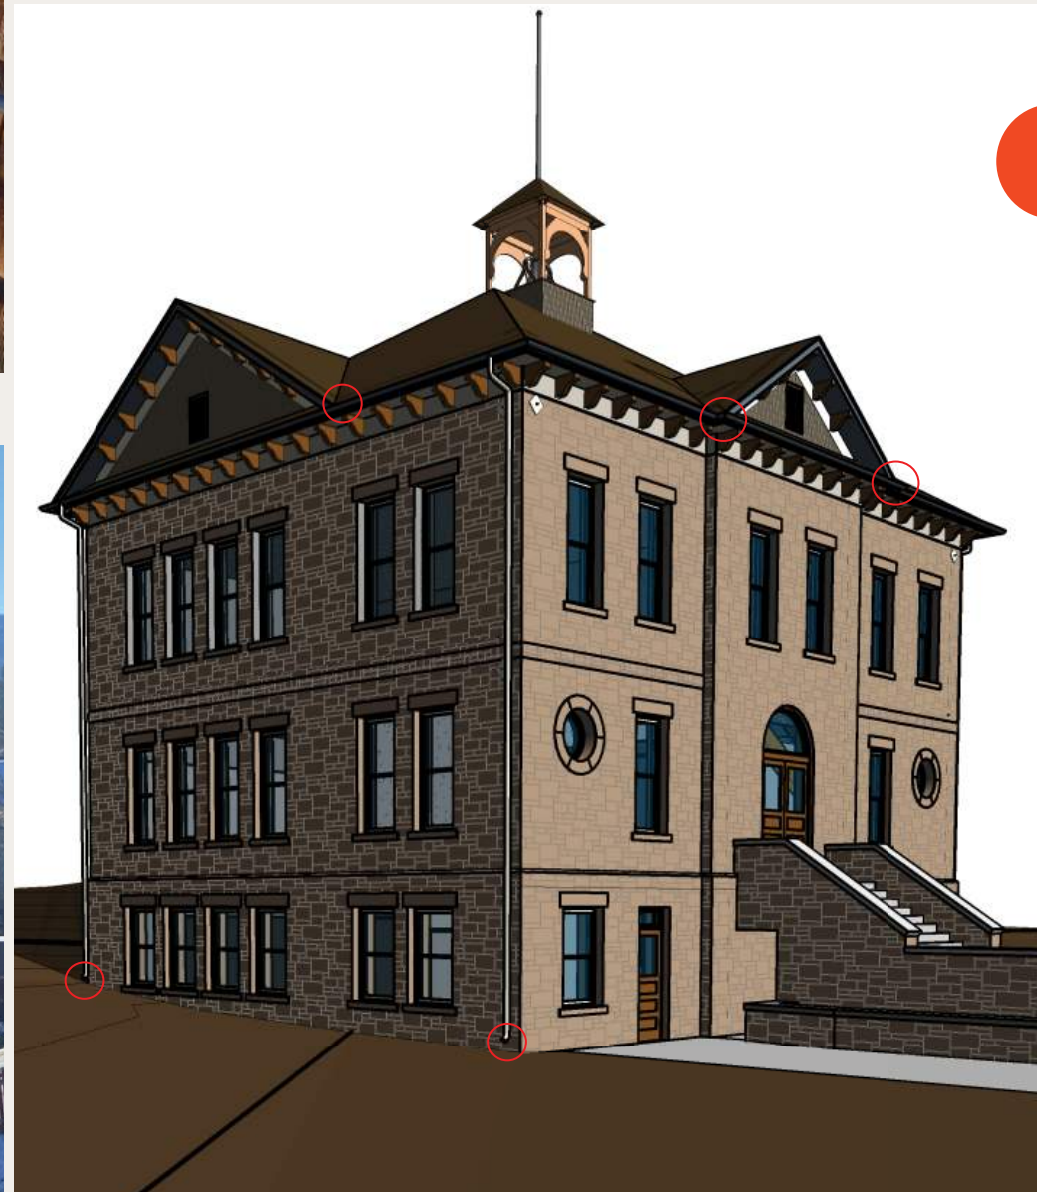
The downspouts are much smaller (3 inches) than intended, limiting the flow of water from the gutters. The downspouts return discharge to the foundations despite the efforts of the staff.

During snow events, ice damming and icicle formation is common at the gutters. Melting snow runs down the roof to freeze again at the backed up gutters. As ice and snow melt at the gutters, icicles form.

- Replace all gutters with 5-inch prefinished metal for corrosion resistance
- Prefinishing involves a factory applied coating that will last longer than paint - select color to match fascia
- Reassess roof runoff and required slopes
- Replace downspouts (5-inch, prefinished metal to match or blend with masonry) and connect to site drainage
- See existing condition drawings for roof, gutter and downspout layout

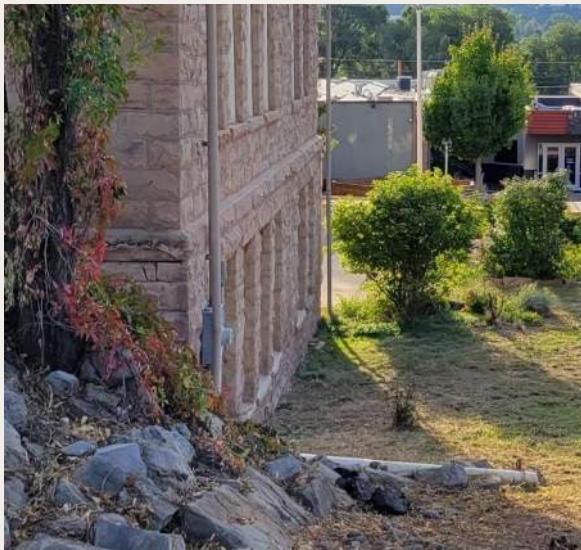
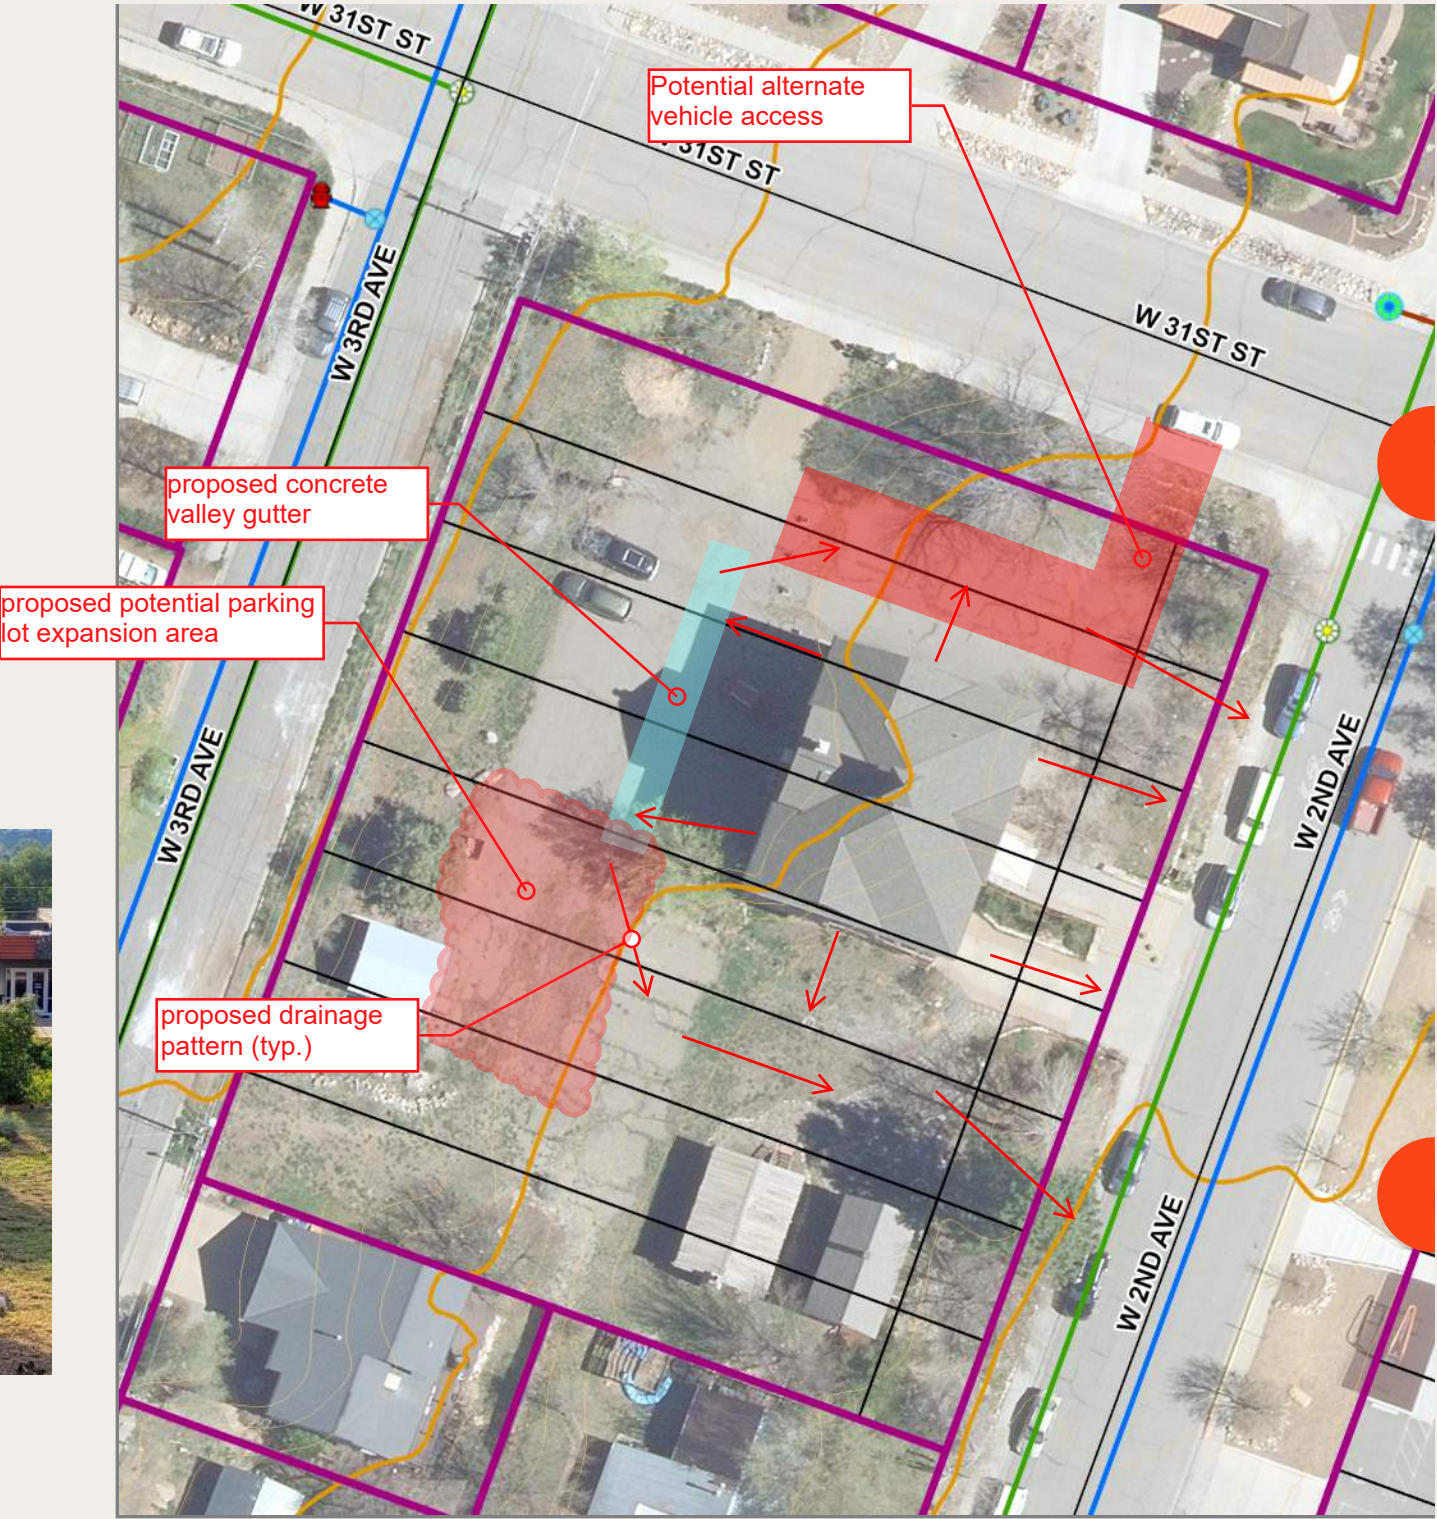
Storm drainage on the existing site is the primary concern and has adversely impacted the Museum building's foundation and subterrain walls.

Presently, the exterior soils and landscaping adjacent to the building have little or adverse gradient away from the building. This condition allows roof drainage and melting snow to saturate the soil surrounding the building and is the likely cause of seepage into the basement foundation walls.

- Please see the civil engineering assessment report
- Geotechnical investigation is required
- Archaeological monitoring is a best practice for scope items that include ground disturbance
- Regrade the building exterior soils and landscaping to at least a 10 feet width at 5% positive gradient
- Include costs for installation of a perforated foundation drain below frost depth
- Remove asphalt slopes on the south side of the building
- Sleeve for utility routing (proposed later)

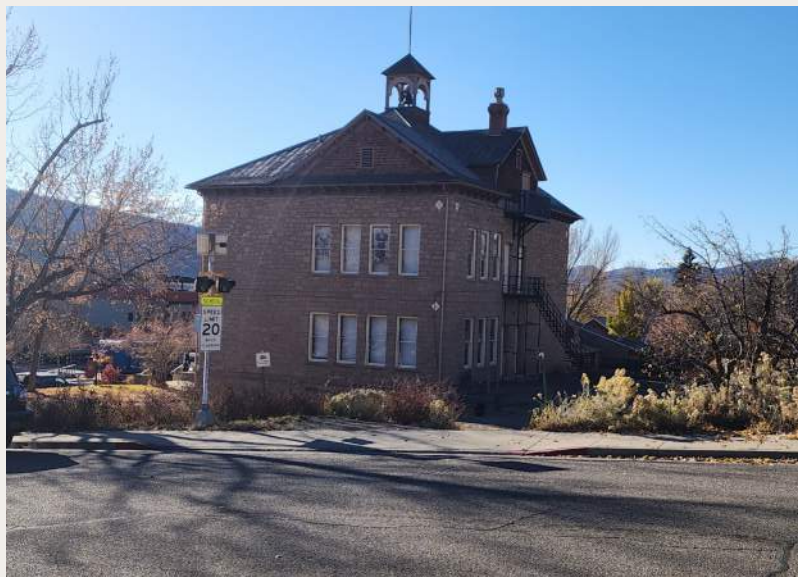
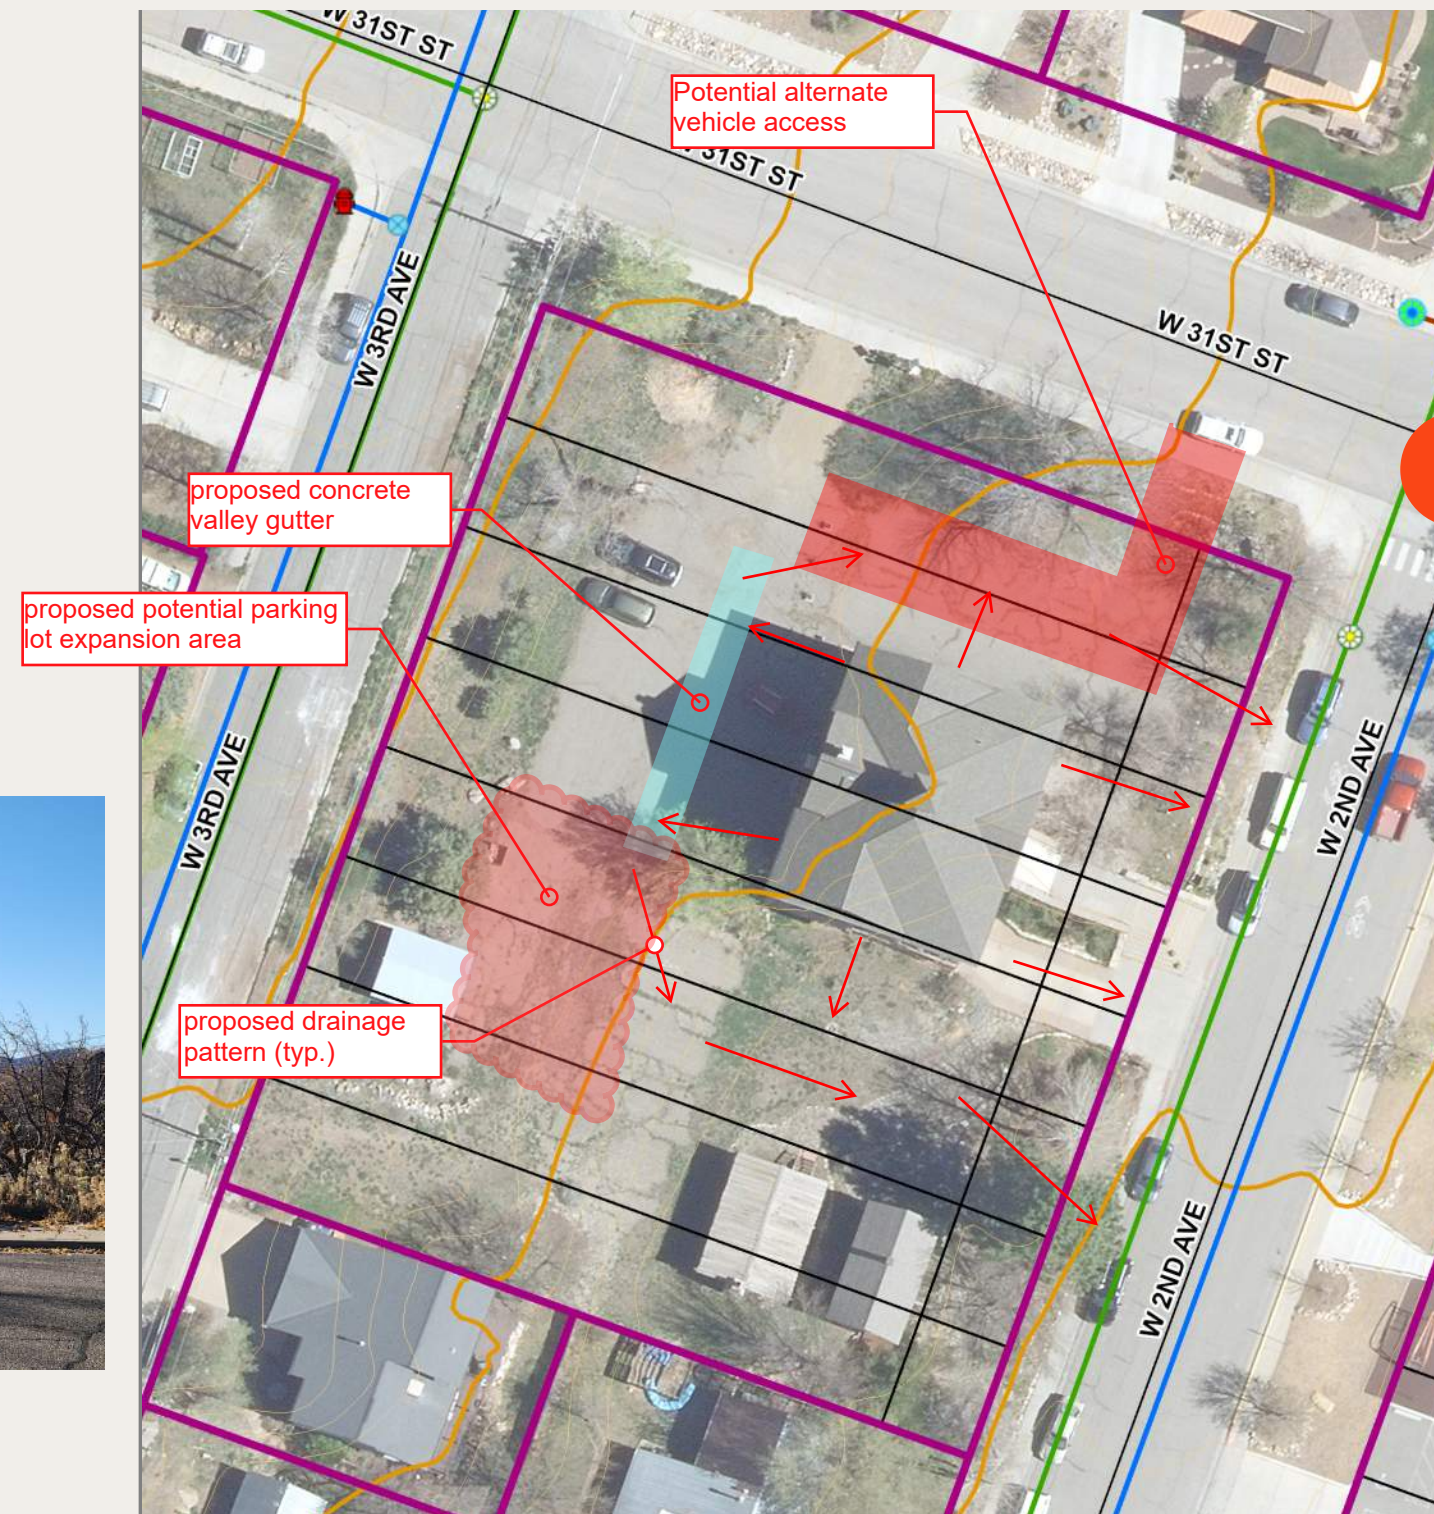
The existing parking area is asphalt pavement in very poor condition and in need of replacement.

- See civil engineering narrative
- Archaeological monitoring is a best practice for scope items that include ground disturbance
- Relocate vehicular access drive to alternate location further east on 31st Street
- Provide new curb cuts at 31st Street
- Replace asphalt at existing parking
- Provide striping and signage for accessible parking

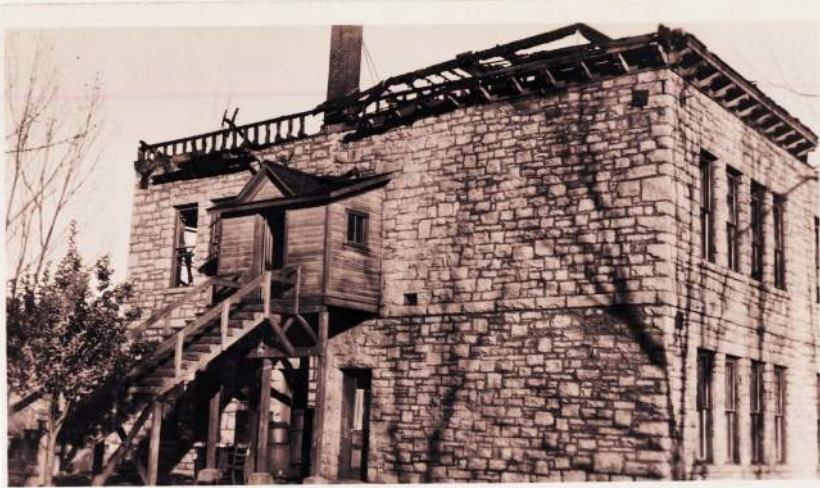
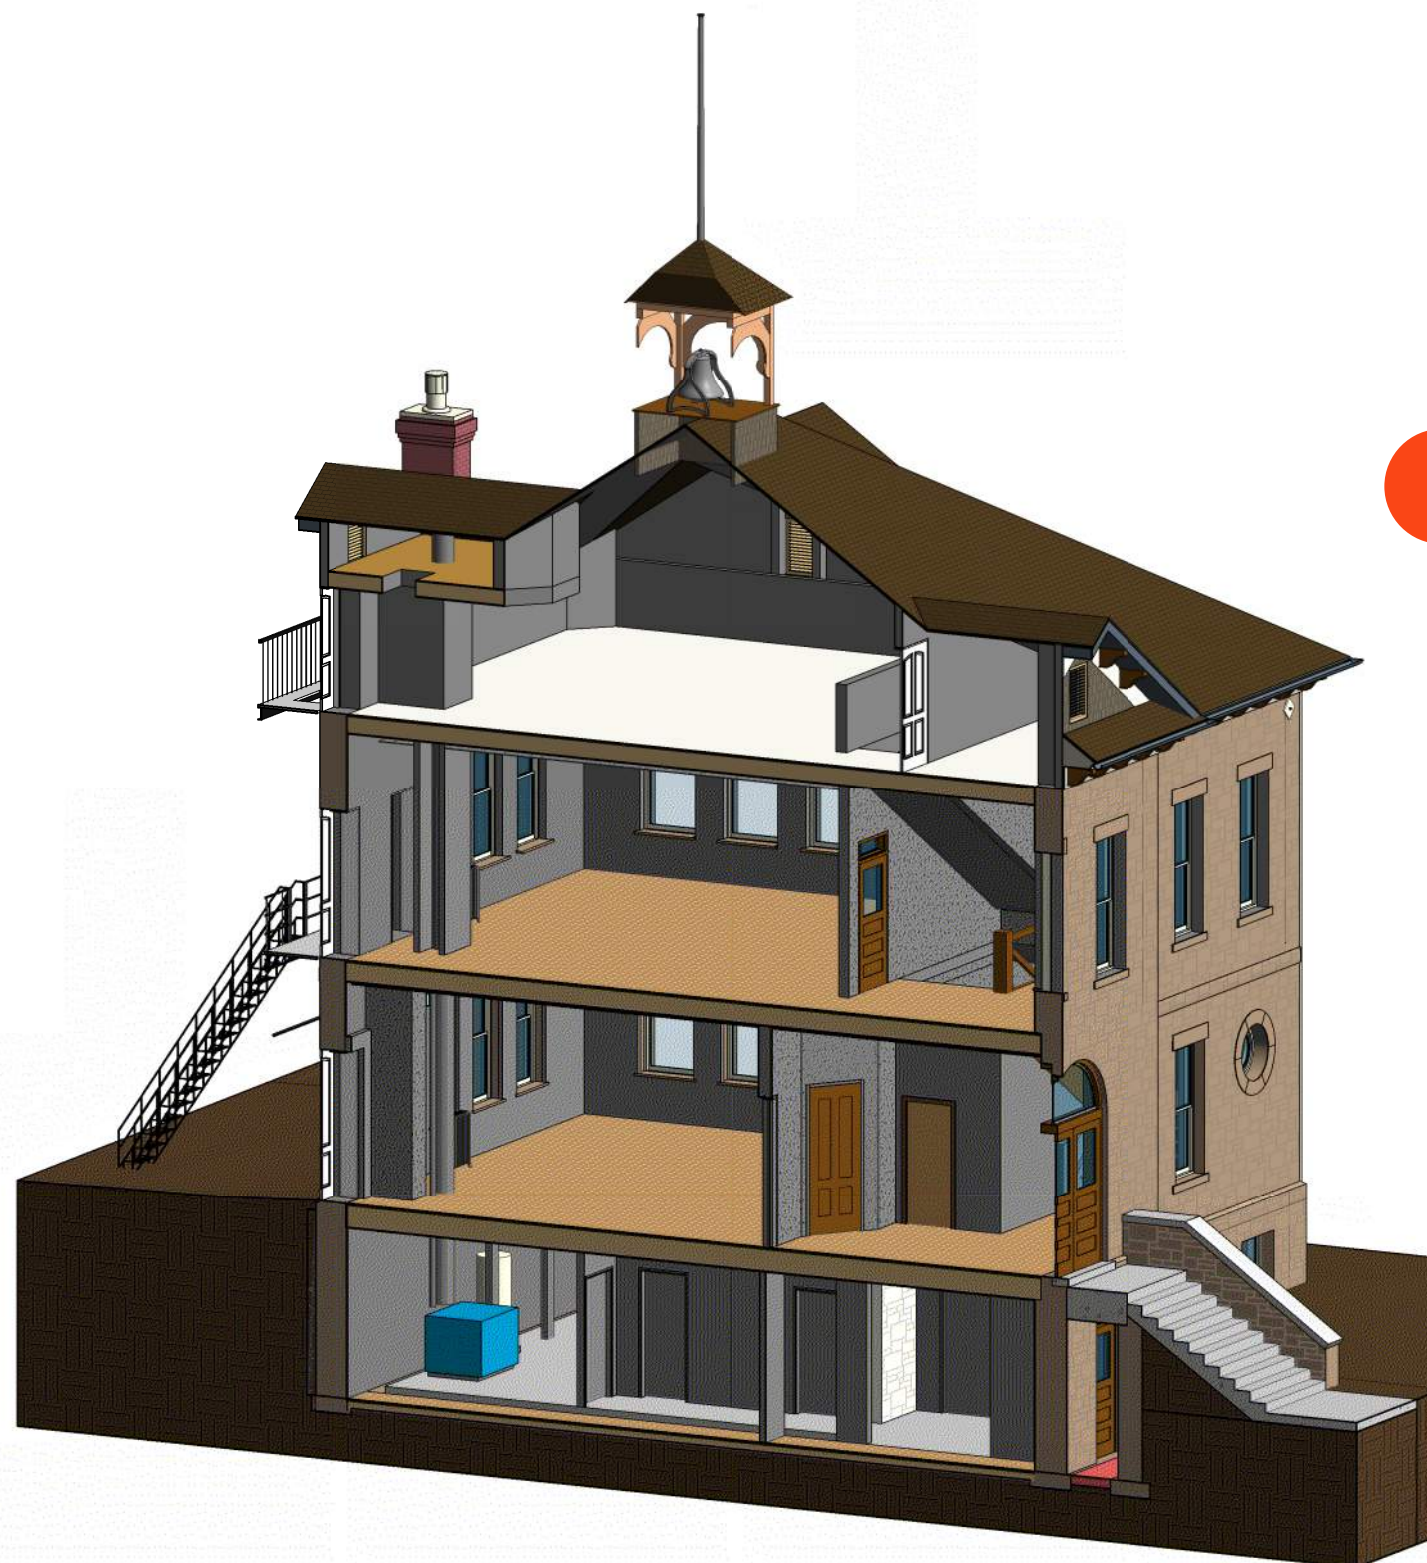
The building does not comply with current building codes for the number of stories above grade and the uses of the building. While as an existing and historic building there is not a requirement to bring it into the compliance, any new construction as part of a rehabilitation must comply. A sprinkler system would bring the building up to code and allow more flexibility for future work.

- Protect people, building and collections
- Install a fire suppression (sprinkler) system at all levels
- For cost estimate, assume a preaction system for all four levels
- Piping can run with other piping for less impact
- Provide new integrated fire alarm system
- Requires new fire line as noted in utilities treatment

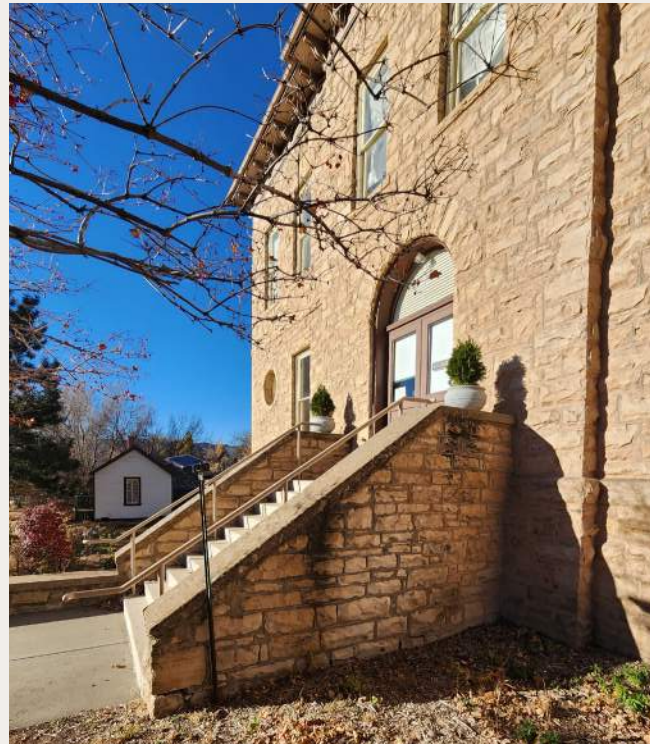
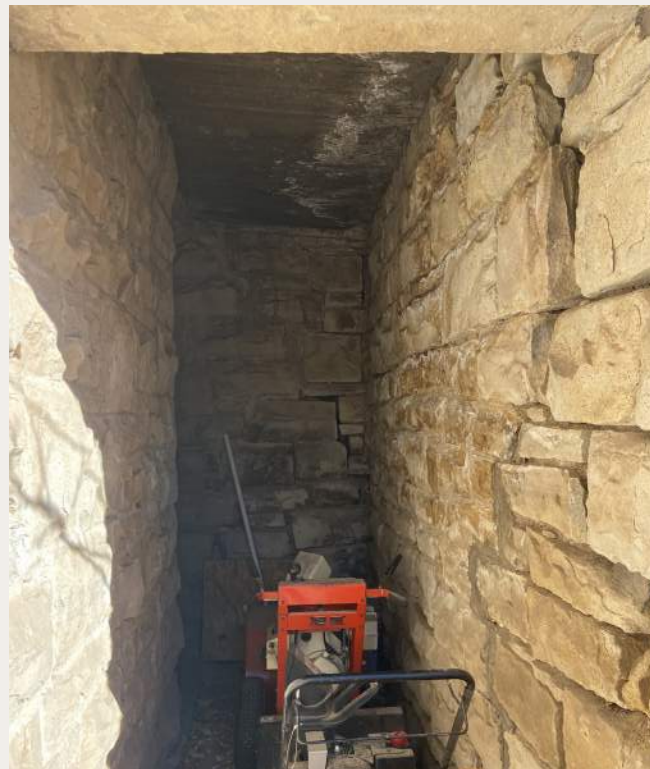
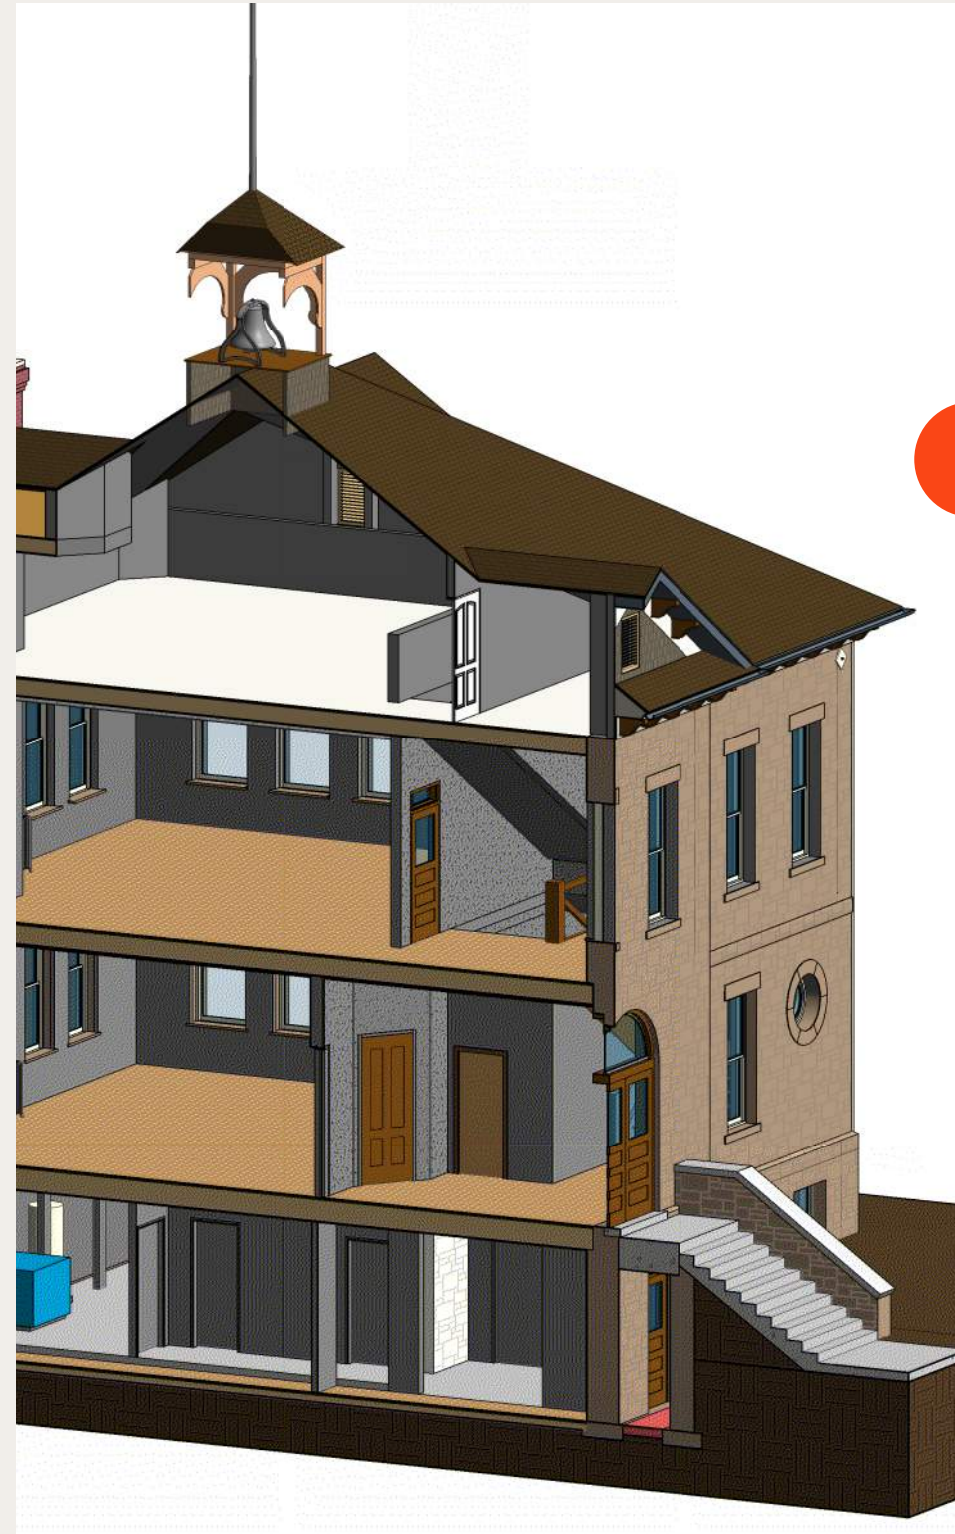
The stone main entry stair shows evidence of movement and deterioration from water intrusion.

The movement appears to be primarily due to frost heave allowed by the very shallow foundations. Elsewhere, the foundations are similarly shallow but have enough weight from the stone walls to mitigate the effects of frost heave. At the stair, there has been movement causing cracking at the interface of the stairs and the building. The lack of a positive connection between the concrete stair and the stone cheek walls offers another point of separation and water entry.

Illumination levels along the entry path are inadequate.

- See structural narrative, geotechnical investigation required
- Provide footing insulation for freeze protection of the shallow footings
- Provide injection grouting and repointing of affected stone
- Add spiral repair anchors to tie concrete steps to cheek walls
- Install new precast concrete cap over flashing at stair cheek walls
- Provide dark-sky compliant lighting fixtures along path

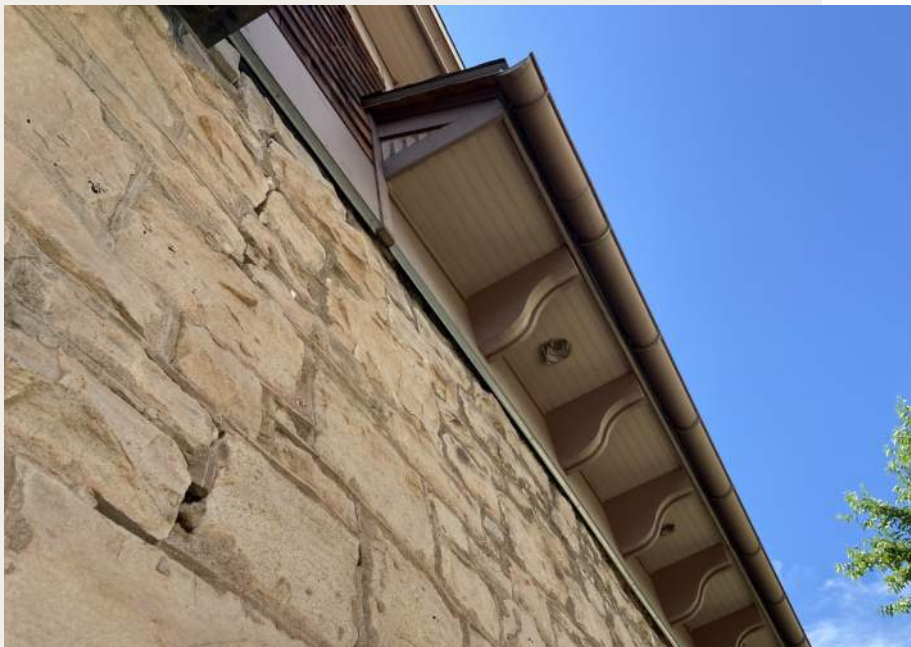
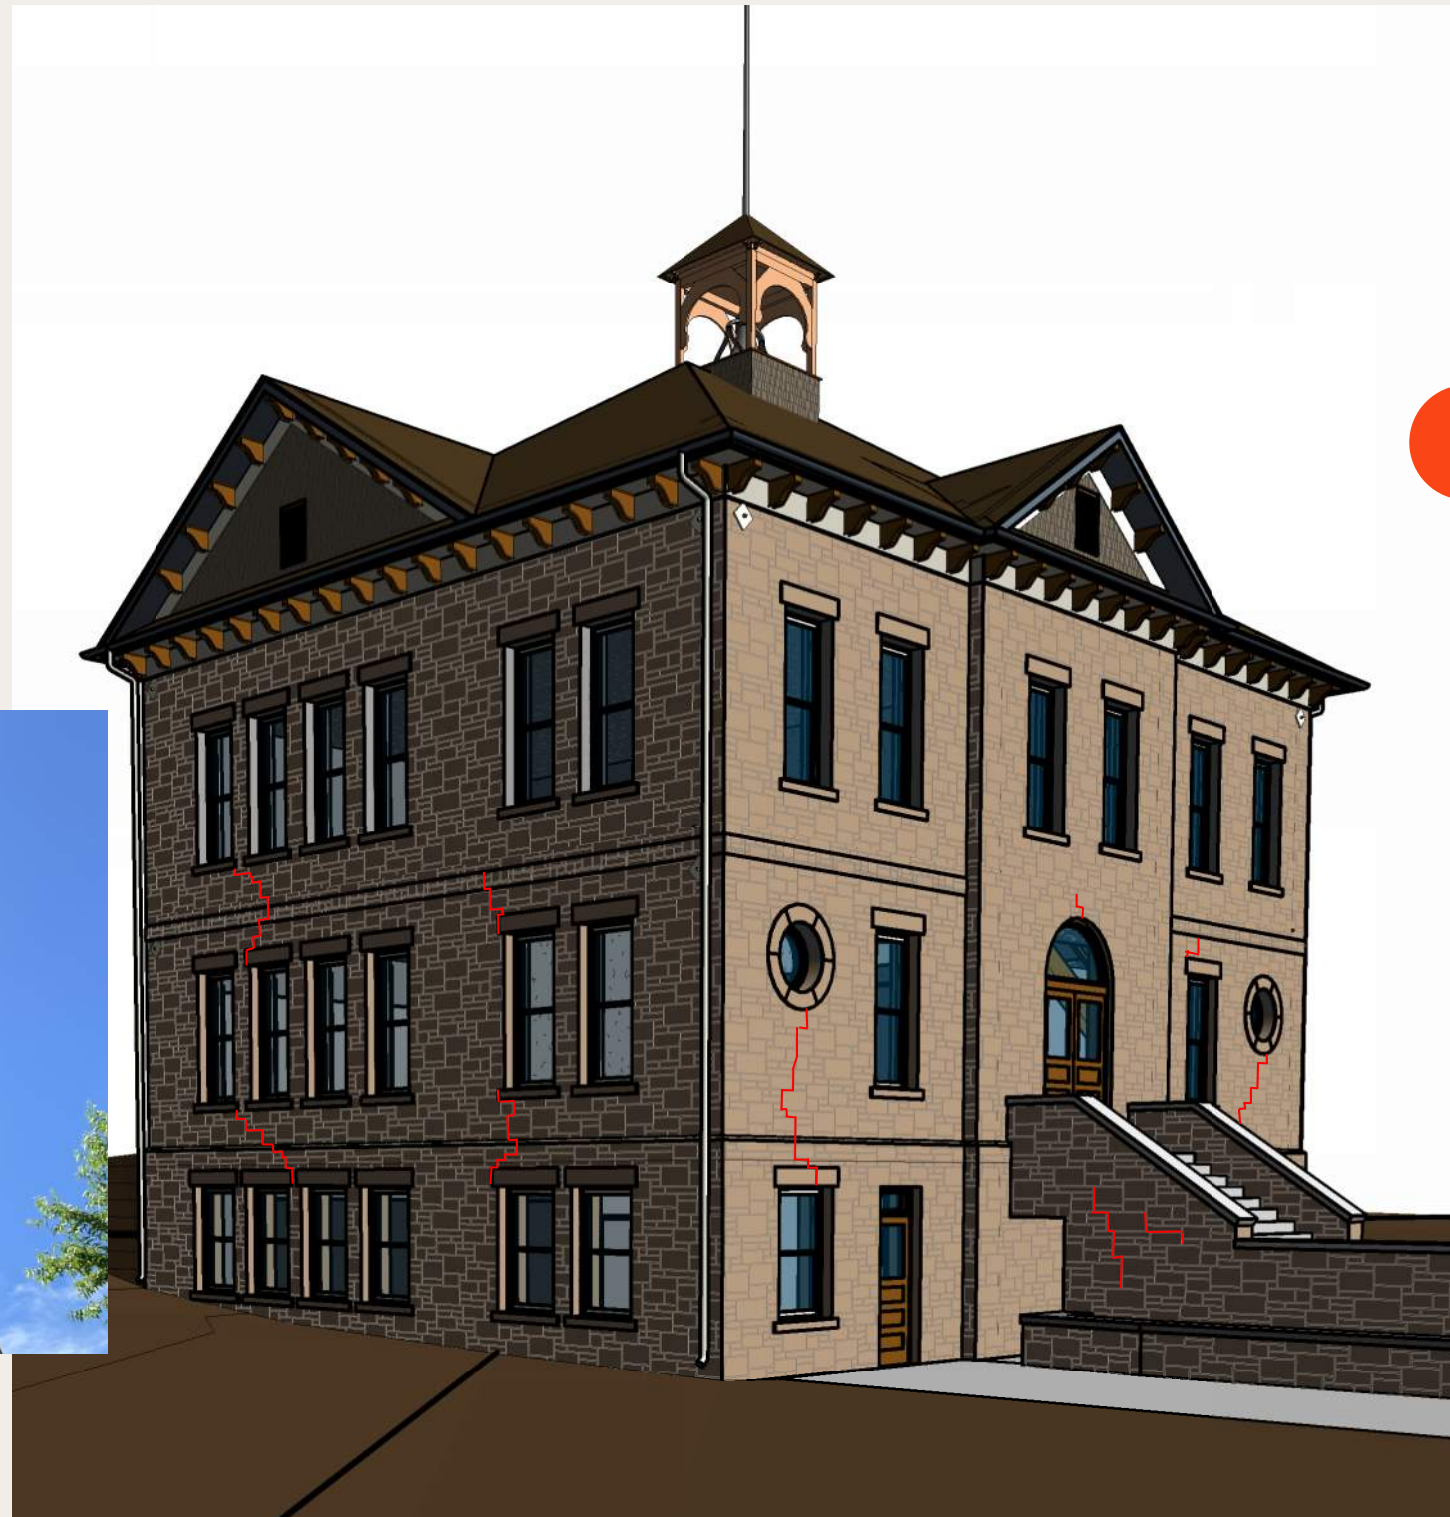
Even if not actively growing, open cracks allow water into the wall cavity

The stone lintel at the basement level southeast corner window is cracked and the crack stair-steps up the wall.

Pointing mortars vary in type, strength and tooling.

- Crack repair - for pricing, assume 15 linear feet per elevation
- Broken lintel repair (1)
- General repointing - assume 10% of each facade, see existing conditions drawings
- Requires mortar analysis
- Further design phases will make recommendations for historically appropriate tooling mortar and profiles

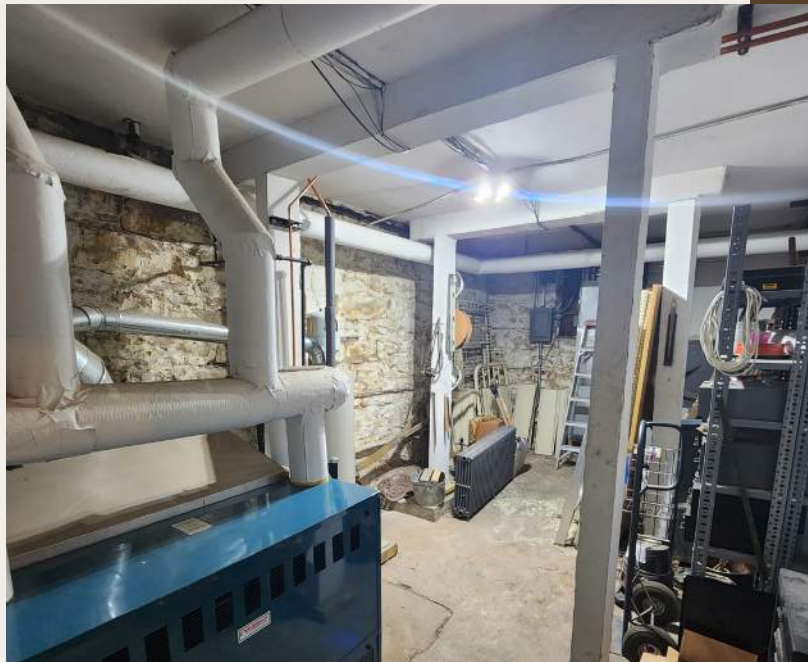
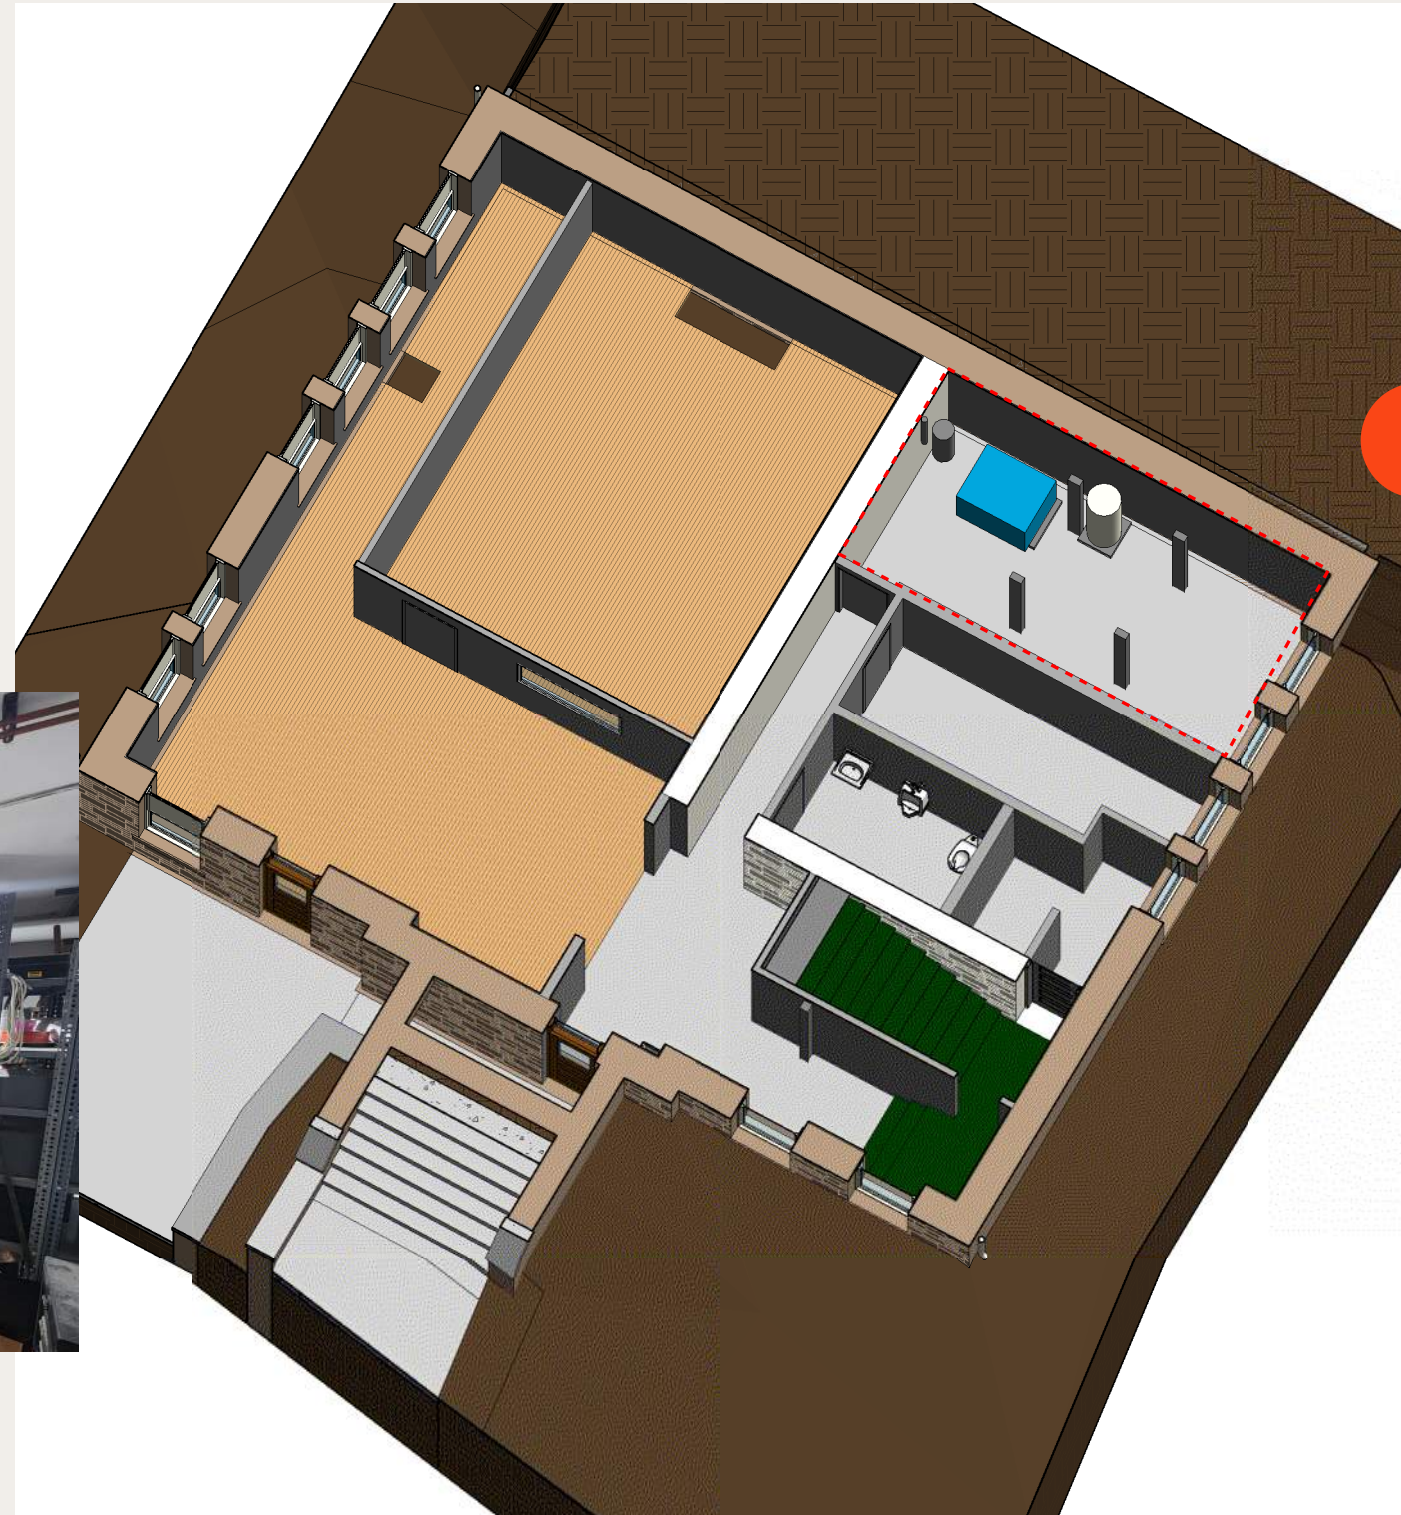
While the school district still owned the building, stacks of books were kept in the room above the boiler room. The books obscured a radiator which at some point failed and saturated the books, causing several floor joists to fail.

The repair at the time was to add posts and beams in the boiler room below to support the joists.

- Sister the (4) existing joists with LVL beams to restore their structural capacity
- Allow the extra posts and beams in the boiler room to be removed
- Replace ceiling following repairs

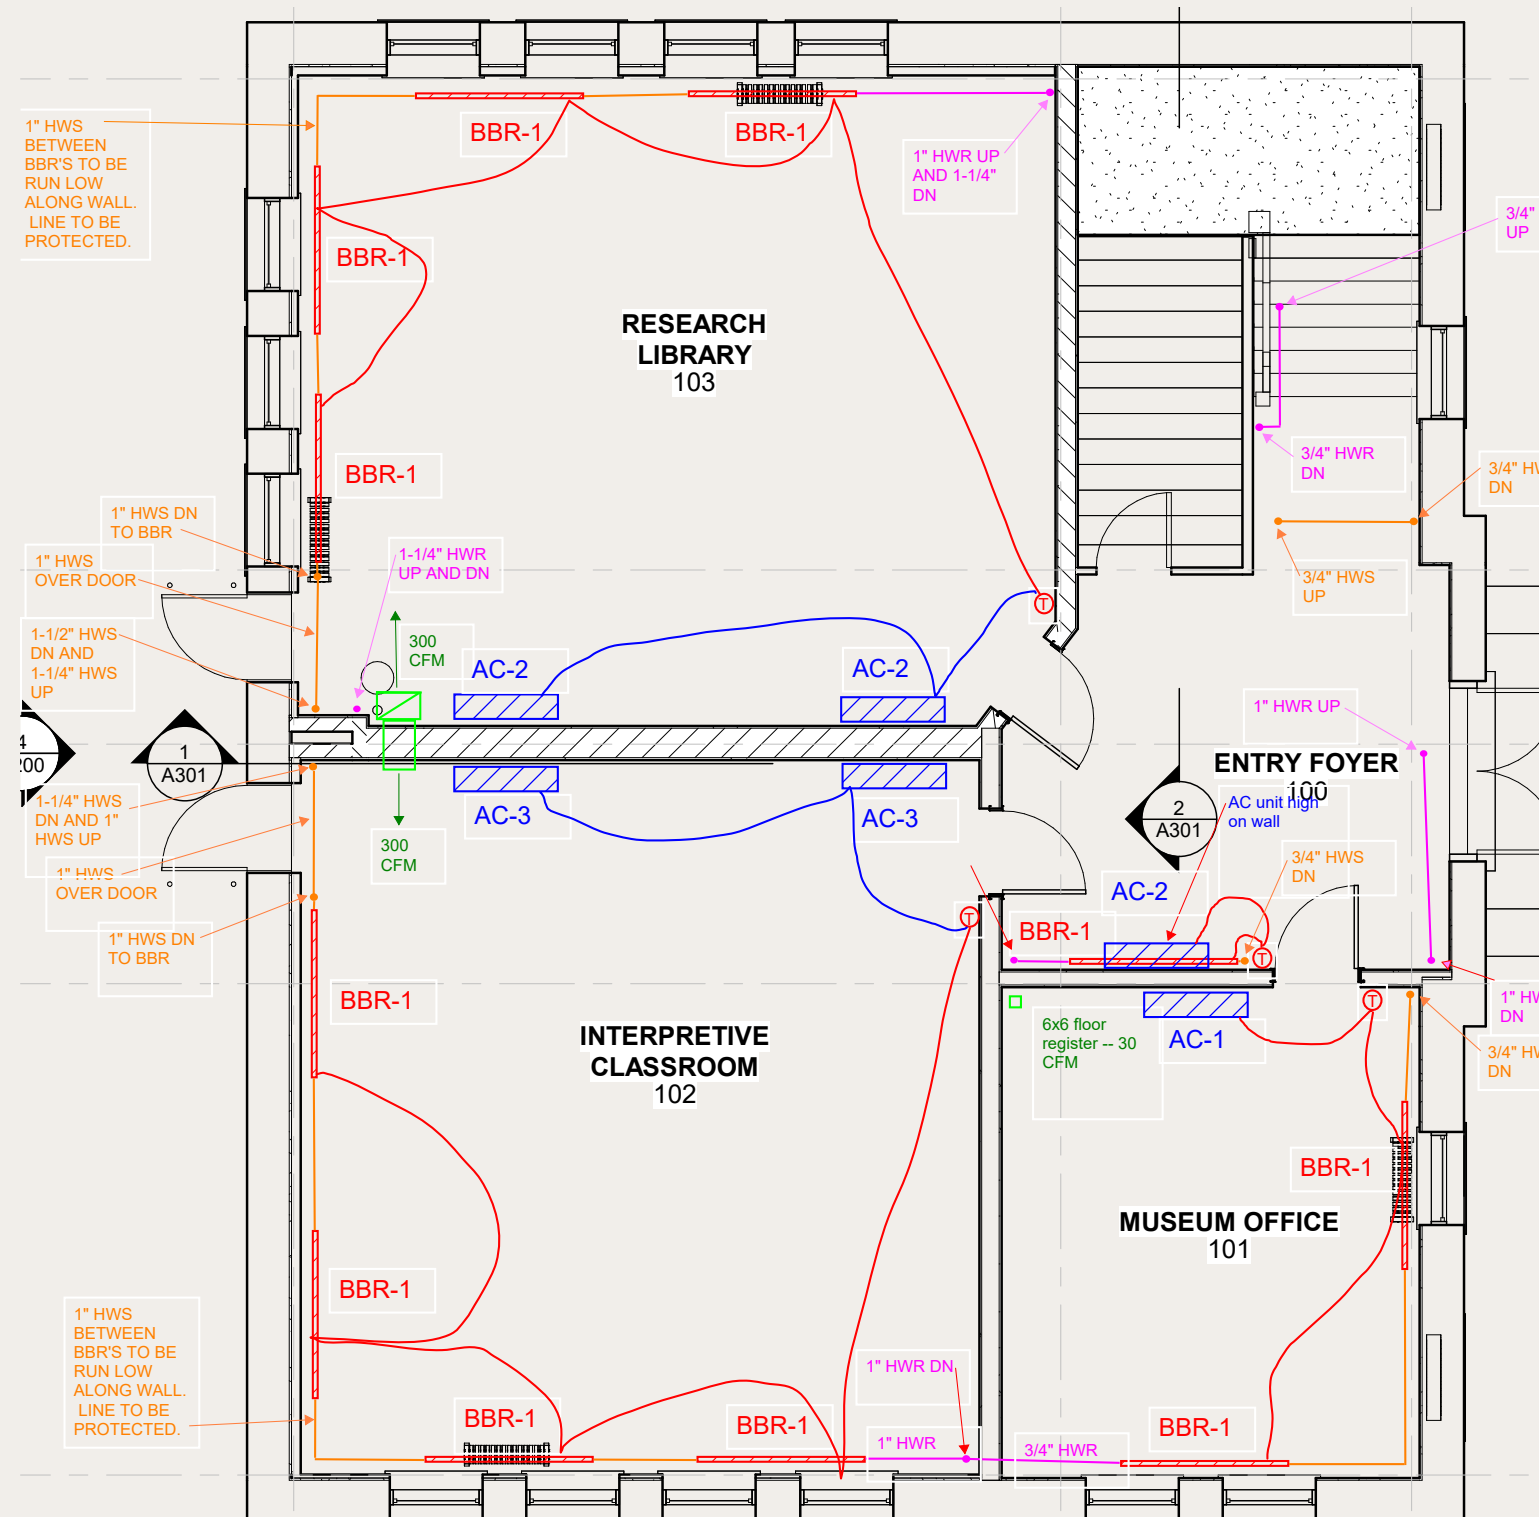
There have been attempts to mitigate the issue by installing valves at the radiators, which can be adjusted manually. However, without a zoned system, both the collections area and the lower levels cannot be kept within comfortable temperatures simultaneously.

- Two new high-efficiency gas boilers sequenced together
- Two-pipe hot water supply and return piping
- All new hydronic radiators - select least intrusive options during further design
- Remove and salvage existing radiators where new radiators must be installed in same location
- Pipes follow existing steam line routes for less impact to historic finishes
- Remove the heat exchanger and pump installed in the attic unit during phase 1, connect to overall hydronic system
