# *Animas Museum Master Plan*

LA PLATA COUNTY HISTORICAL SOCIETY  
FINAL MASTER PLAN  
SHF 24-PL-014  
OCTOBER 9, 2024

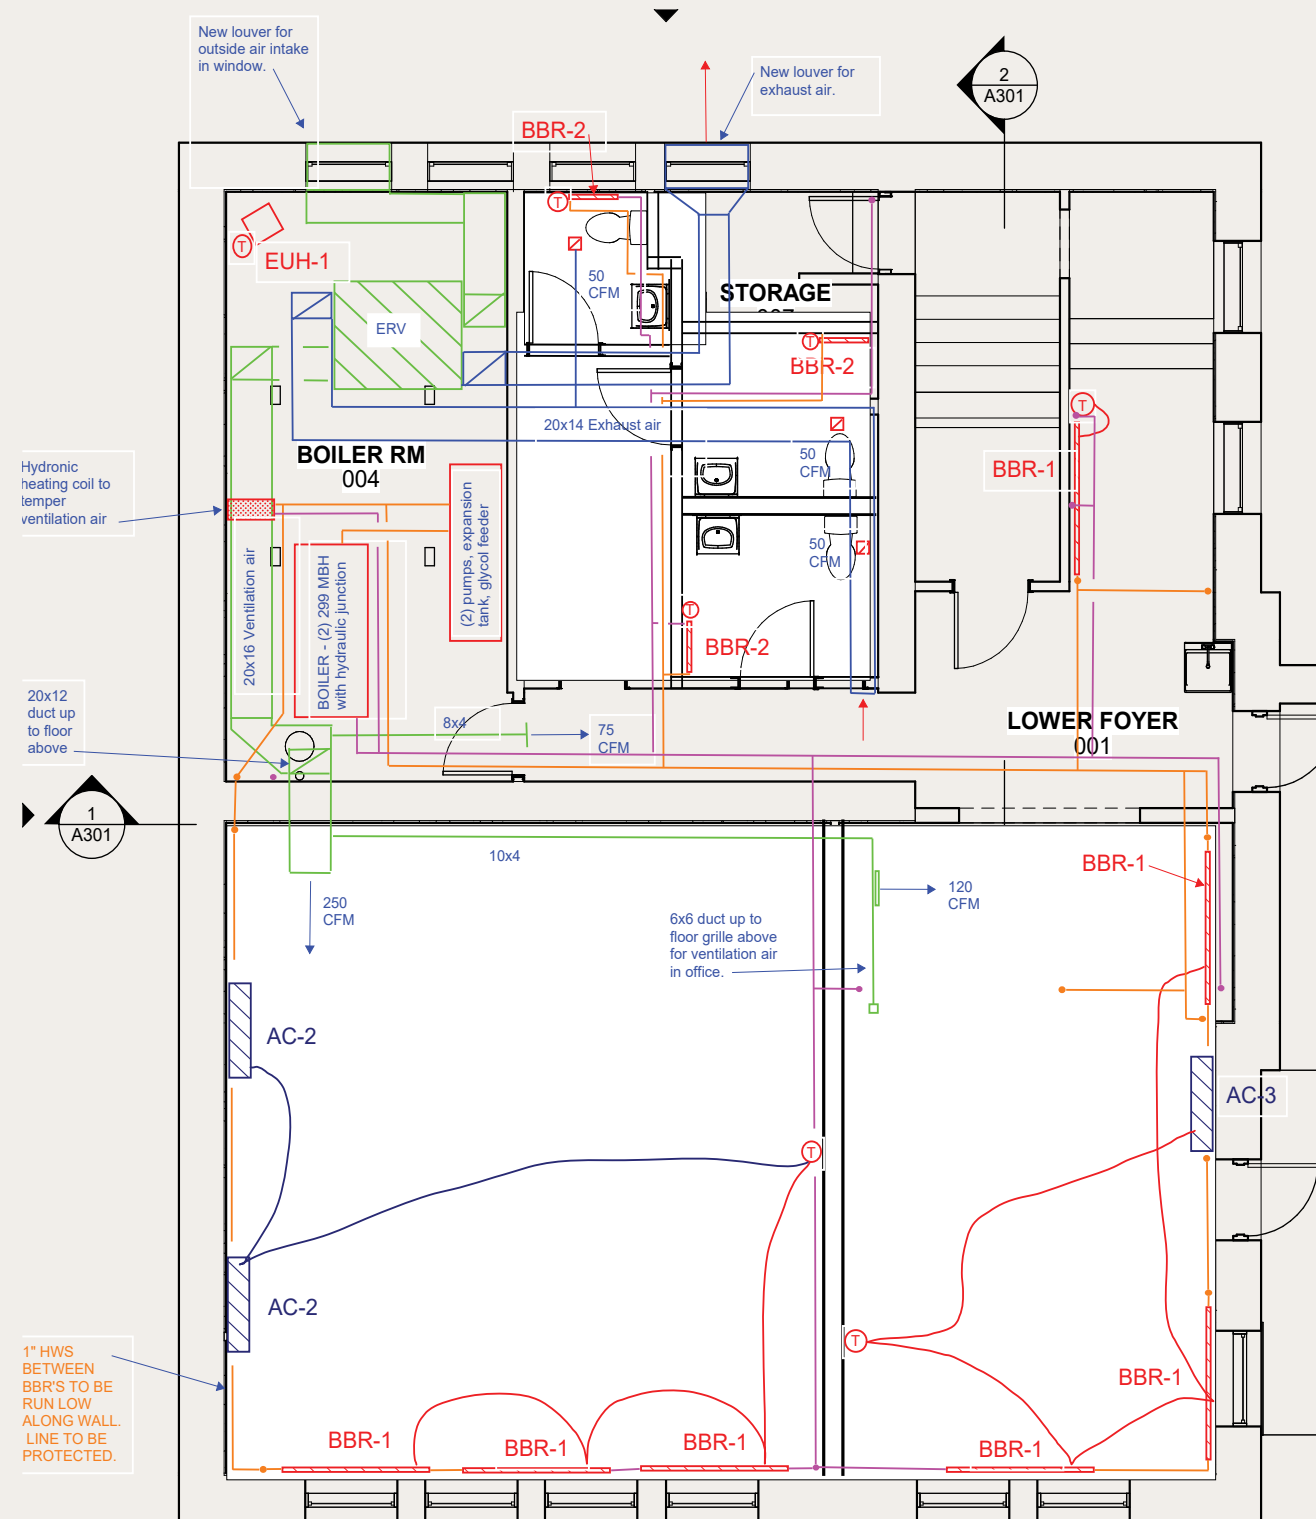
There is no active mechanical ventilation for the basement, 1st Floor, or 2nd Floor. Ventilation for these areas is only provided when windows are opened to allow fresh air into the space. This practice is not recommended for a museum due to the sensitivity of the collections.

The attic level does not have active ventilation air either; however, this is a different use of space, and maintaining a consistent temperature is critical, and outside air is not recommended.

There are also two individual restrooms, one on the basement level and one on the attic level. The basement-level restroom has no exhaust or exterior openings to allow odors out. The attic level does have a small exhaust fan.

- Energy Recovery Ventilation System
- ERV unit and window intake in boiler room
- Air tempered by other systems, then distributed
- Also provides exhaust required for restrooms
- During further design, select units, locations and routing to minimize impact to historic fabric

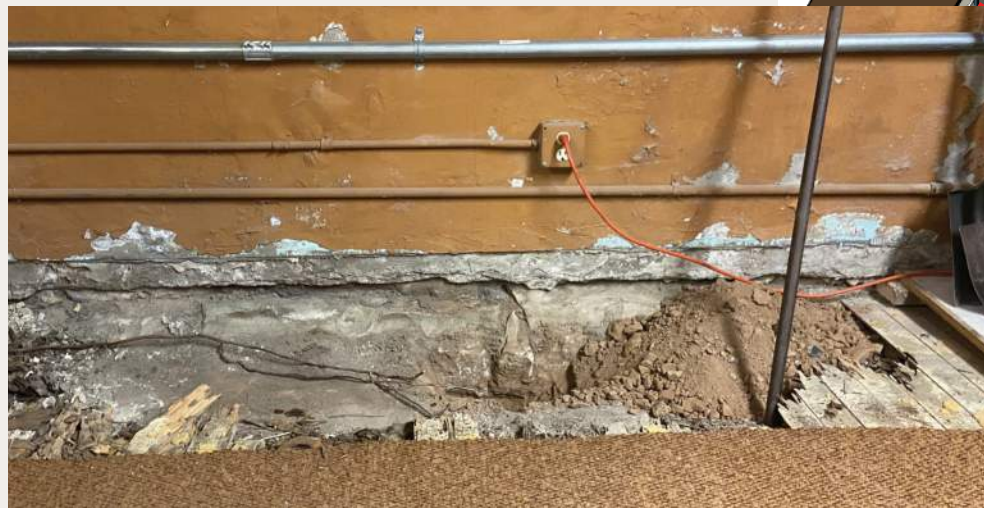
The existing grade directs water against the building. Moisture issues are manifested in the damaged and deteriorated basement floor structure. The existing system with timber sleepers resting on grade and supporting wood subfloor does not meet current codes and has contributed to the deterioration of the floor.

- See structural report and existing condition drawings
- Archaeological monitoring is a best practice for scope items that include ground disturbance
- Geotechnical investigation and further structural load path analysis required
- Preferred option: replace historic wood joist floor system with a concrete slab on grade (in area shown inside red dotted line)
- Demo non-historic internal partitions to facilitate work - shore main floor structure
- Current wood flooring is understood as subfloor - no salvage required
- Further design phases to make recommendations for silverfish and insect mitigation as well as finish materials

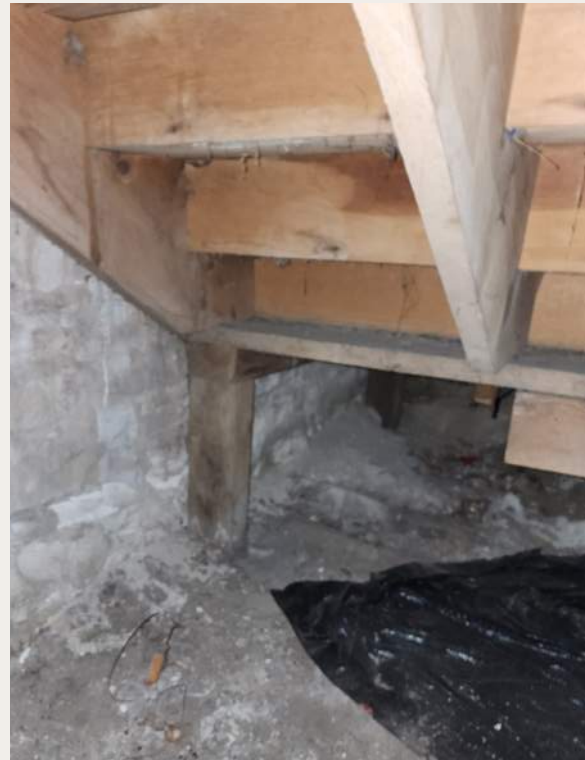
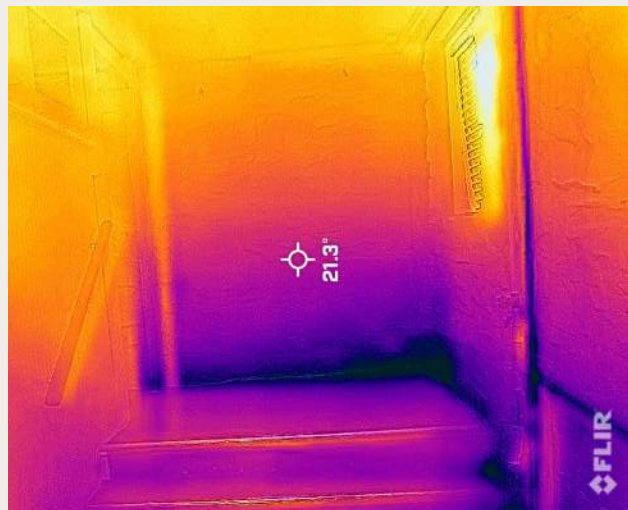
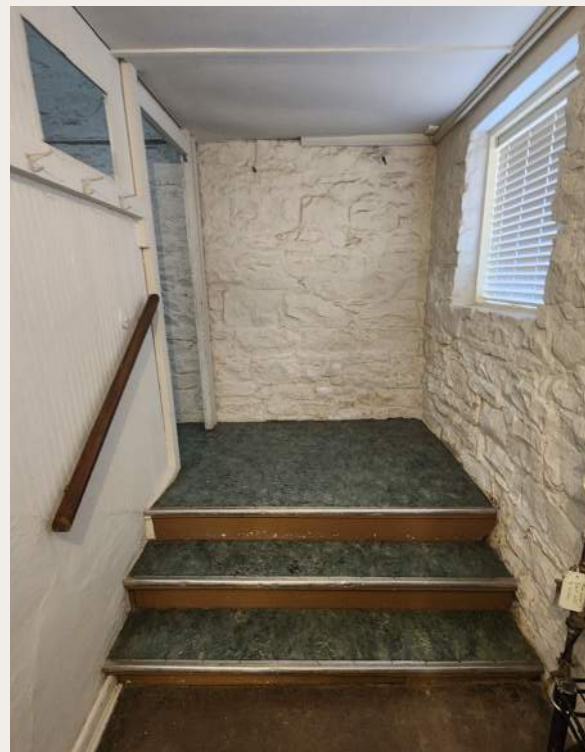
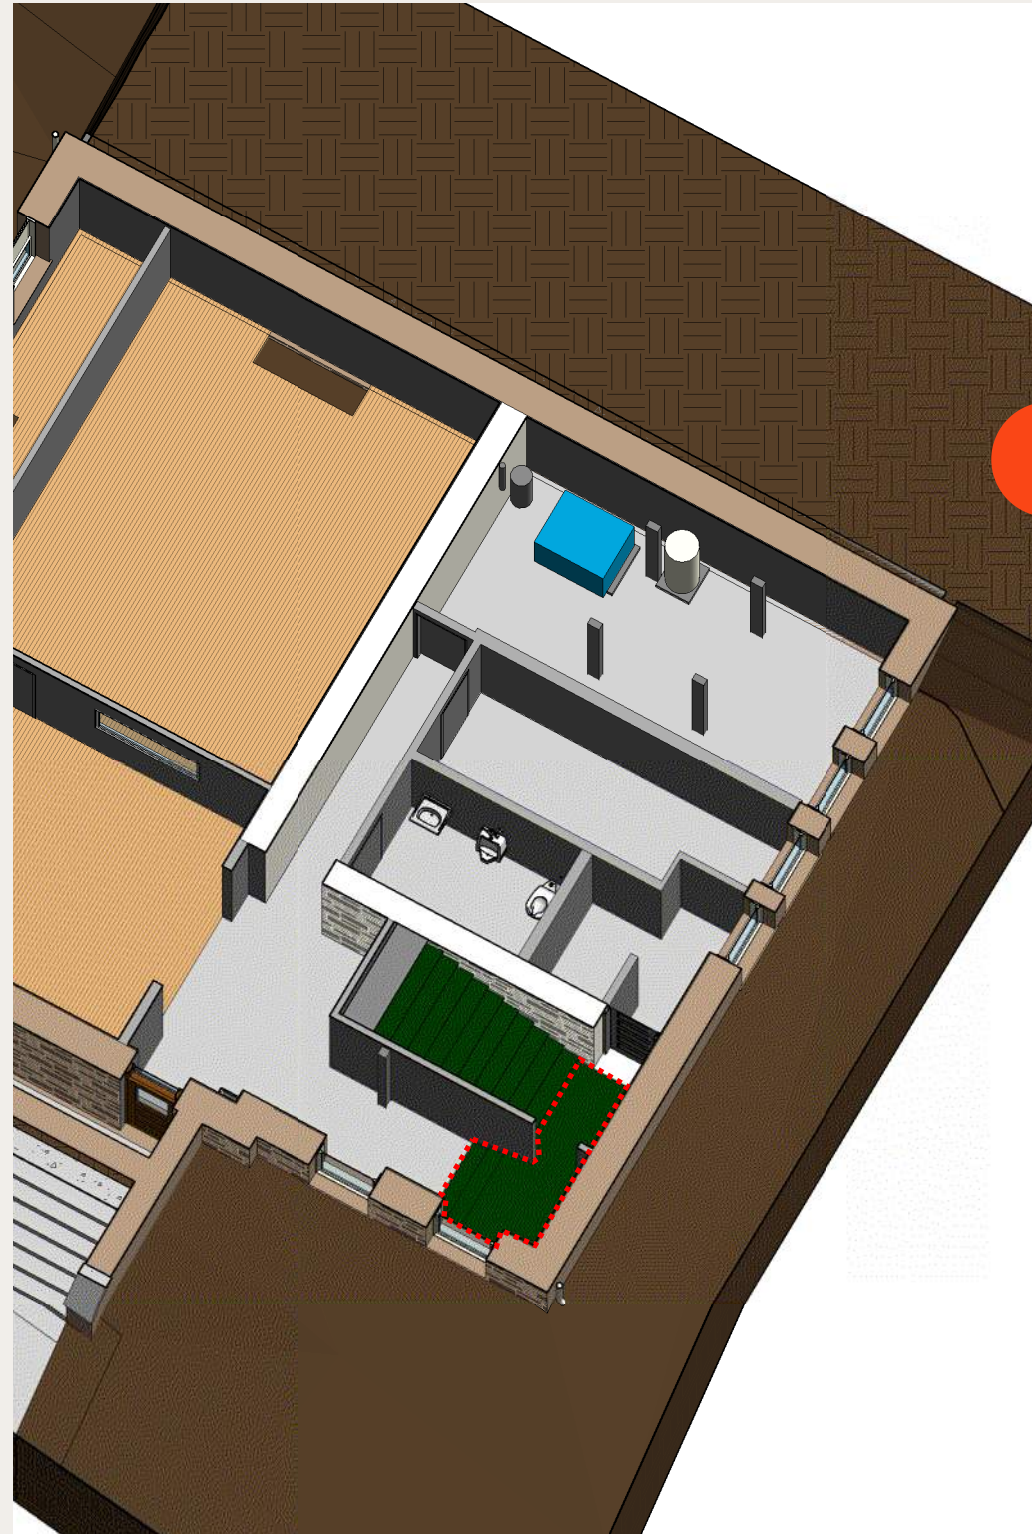
The stairs from the main floor down to the basement floor do not have adequate foundations.

The midway landing is sloped and makes egress dangerous.

- Replace the wood stair from the main floor to the basement (rather than just the section shown in red) with a new wood stair and structure resting on concrete foundations or a concrete slab
- These stair sections are not historic - protect upper historic stair and railing to remain
- New finish material to be determined

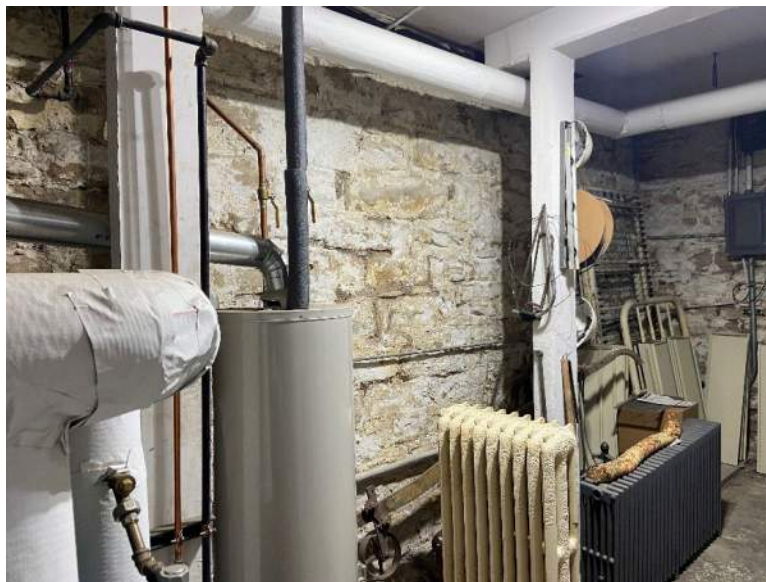
The effect of over a century of drainage issues is more visible at the interior. At the portions of the basement walls that are below grade, moisture transfer is manifest in peeling paint and efflorescence at the wall in interior. The boiler room is shown here.

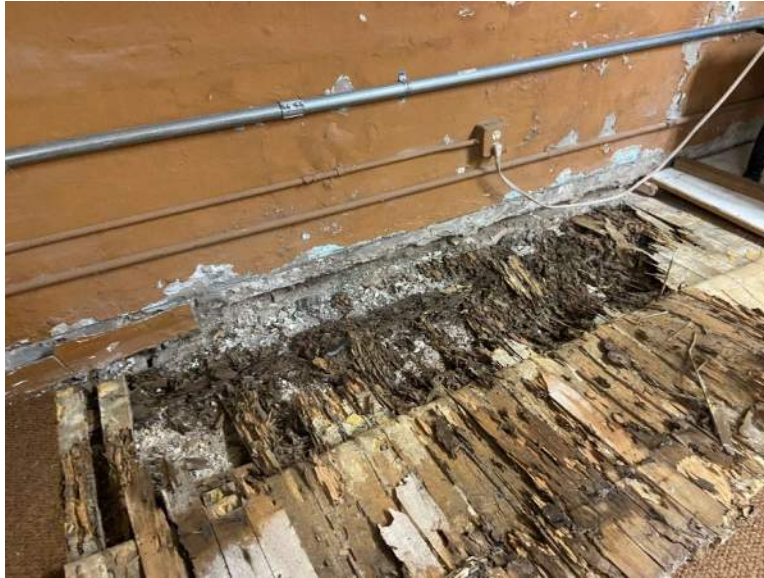
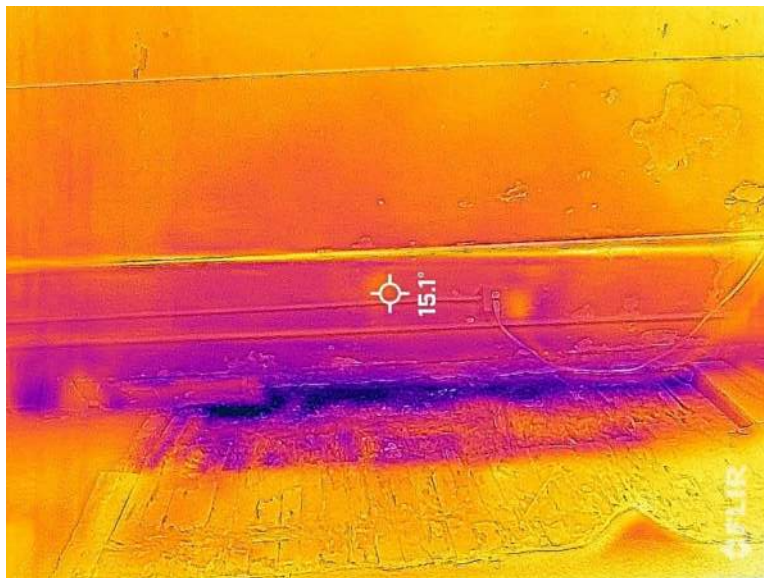
The basement floor structure also bears witness to these issues. Floor joists, sleepers and ends of the floorboards themselves are rotted at the west wall as shown in the first image below. In the thermal image of the same condition, the moisture in the foundation wall reads as blue (cold/wet) in contrast to the yellow (warm/dry) areas.

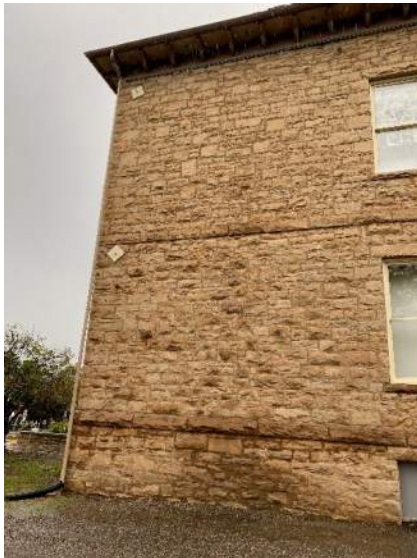
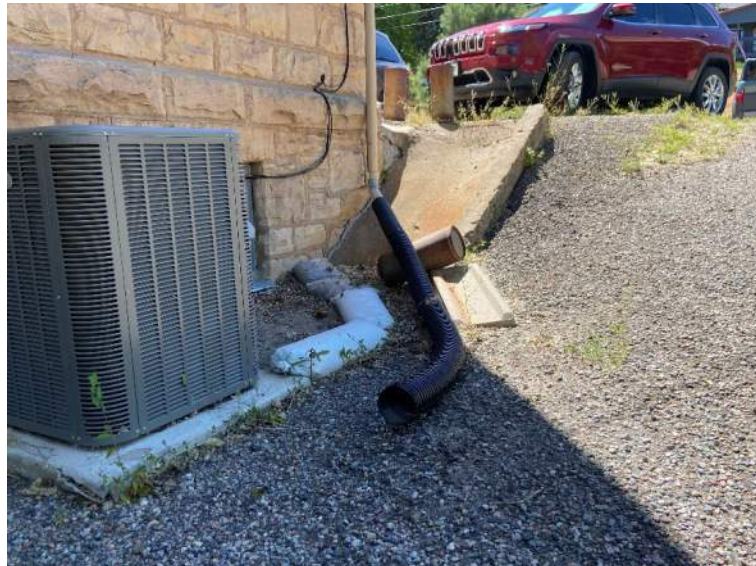
Several issues are immediately evident. During rain events, the gutters overflow, particularly at the valleys formed by the gables. The image at left below, taken last September and provided by Susan Jones, clearly shows dampness at stones below the valley of the west gable. The resulting drip line at ground level is notable even in dry conditions.

The downspouts are much smaller (3-inch diameter) than those specified, limiting the flow of water from the gutters. The downspouts discharge too close to the structure, but this condition is carefully ameliorated by the staff in the form of various piping and tubing that can move water further away. These are temporary expedients that require constant monitoring to ensure nothing is loose. The image below shows the northwest downspout over the sharply sloped concrete gutter from the 1930s, and the various methods used to keep the water away from the window and the foundation.

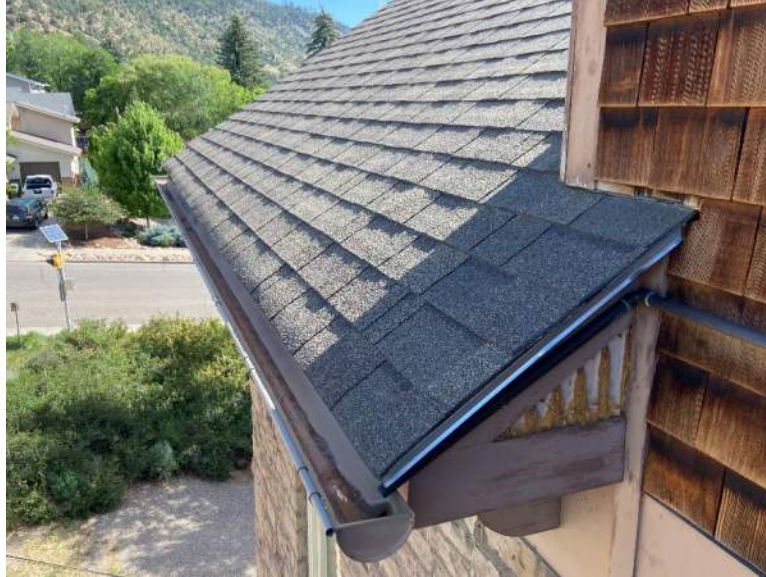
The west gutter has holes in its base, likely caused by corrosion of the painted galvanized gutter. The condensate line from the attic condensing unit drains into the gutter at this location and may be the cause of the corrosion (shown below).

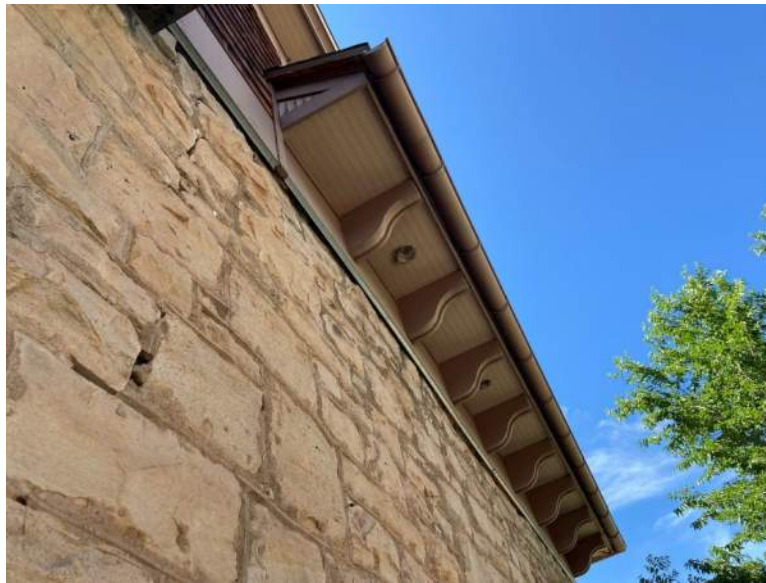
The exterior wythes of the masonry walls are in overall good condition, showing little of the erosion, bedding issues or staining common to sandstone. Several large, open cracks persist on

the exterior. These are not new cracks but should be studied anew due to the new roof structure loads, and also repaired as open cracks allow liquid water into the wall assembly and leave it vulnerable to the deleterious effects of freeze-thaw.

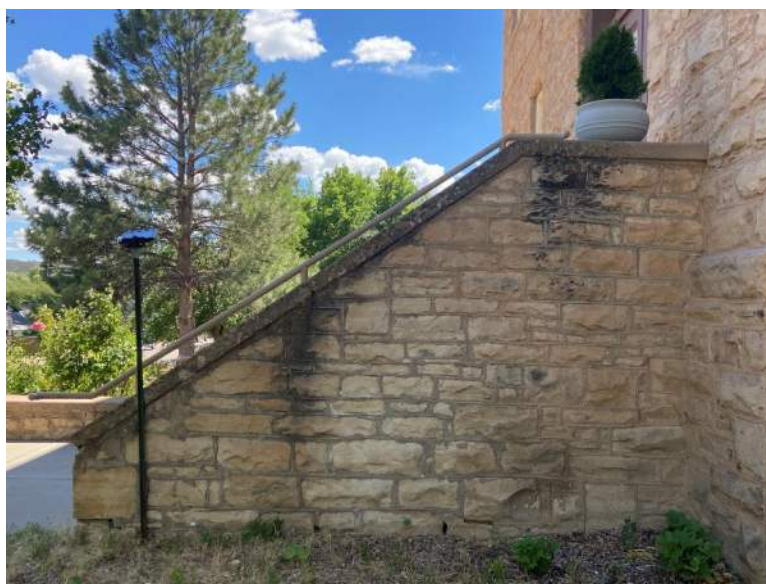
The masonry was extensively repointed with the current convex beading technique sometime in the 1930s, as explained by facilities staff and visible in historic images. Areas previously covered by the concrete gutters, such as at the southeast corner, show a more typical raked joint. A more thorough investigation of masonry pointing is needed, especially at upper reaches, but was in fair to good condition where observed, except at the exterior east stair (shown below). The 2018 HSA indicates that a mortar analysis and report were completed for a 1999 architectural assessment, but our copy of that assessment does not include it. Such a report would be a valuable resource. *Update: Mortar analysis received 8/9/2024.*

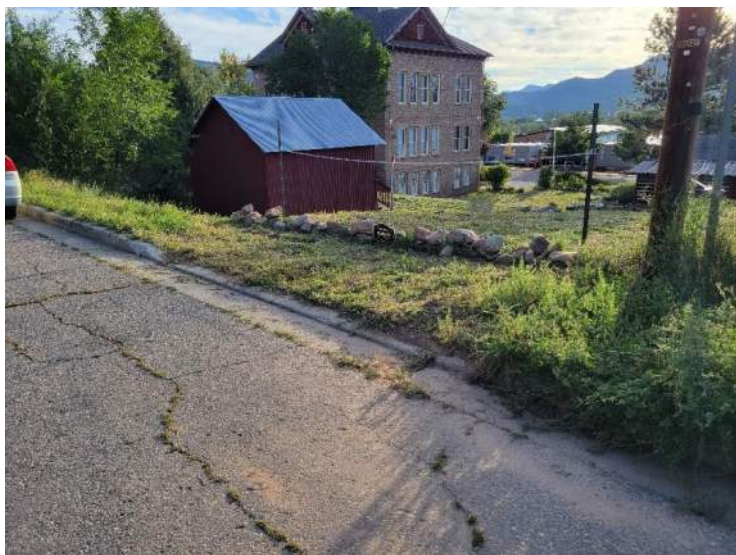
*Figure 2 - West 3rd Avenue driveway*

A secondary driveway access into the property is located at the southwestern quadrant on West 3<sup>rd</sup> Avenue. This access is currently blocked off and not used given the significant elevation differential between the west 3<sup>rd</sup> avenue roadway and museum's parking lot. (refer to Figure 2).

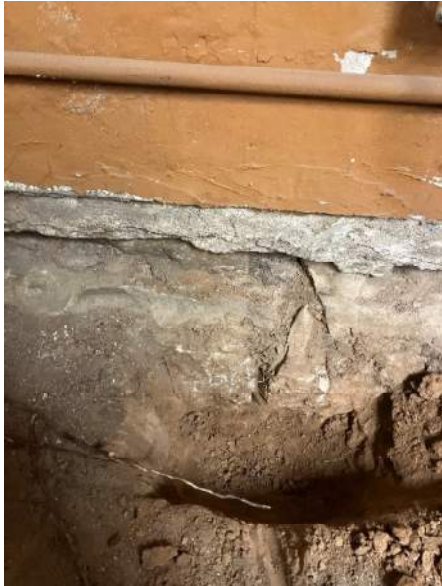
Exposed Foundation Stone

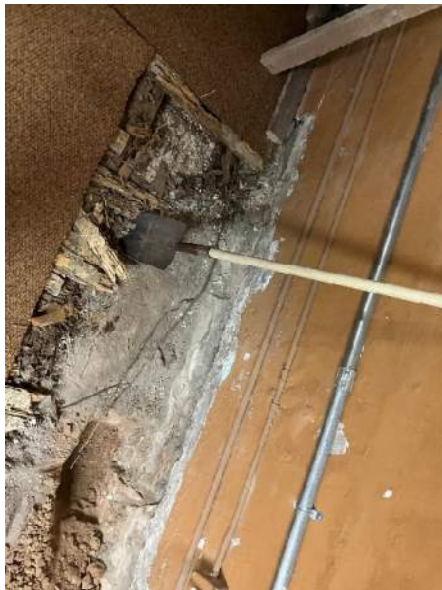
Deteriorated Floor Framing on Sleepers on Grade

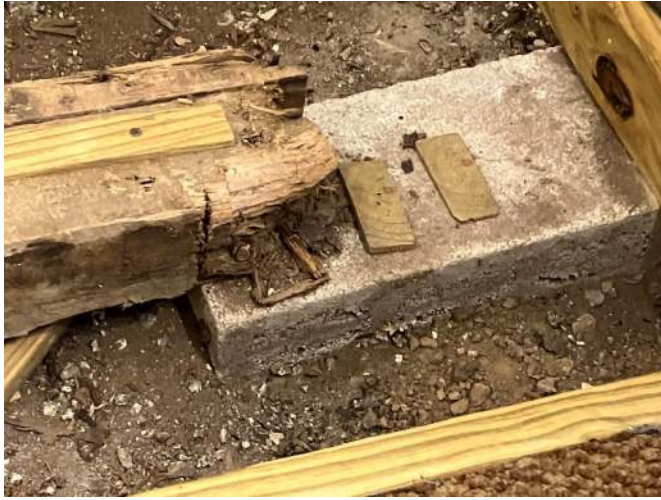
Second Area of Deteriorated Floor

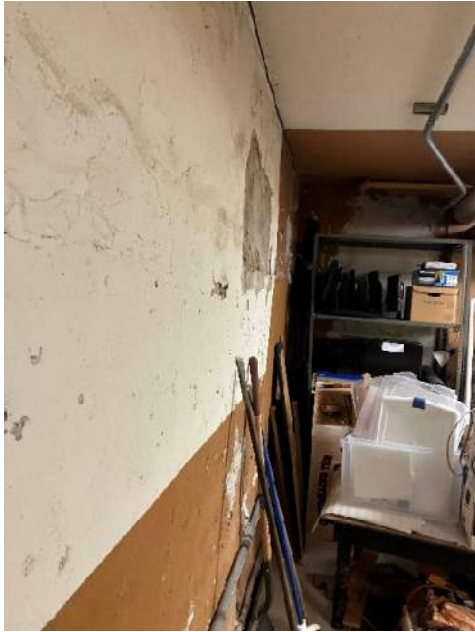
Bow in Northwest Basement Wall

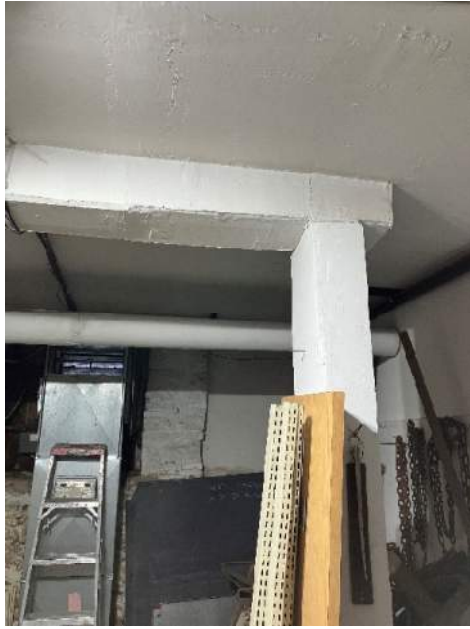
Frames in Boiler Room Supporting Broken Floor Joists

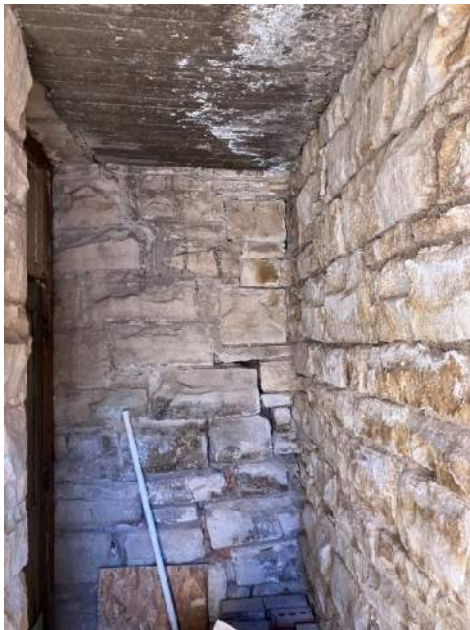
Stairstep Cracking from Movement of Entry Stair

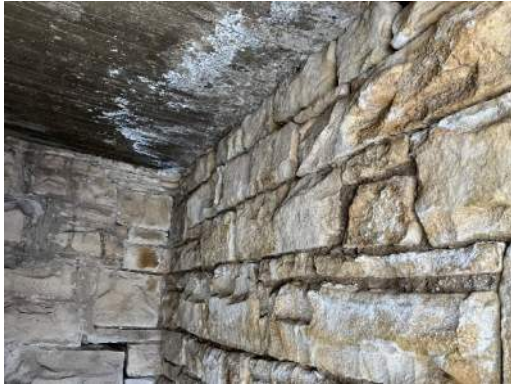
Deterioration at Stone Stair from Water

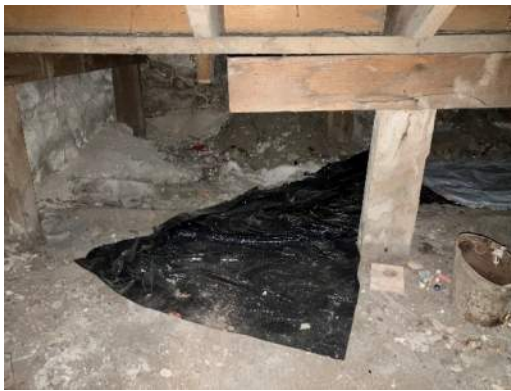
Support at Lower Stair Landing
