# *Animas Museum Master Plan*

LA PLATA COUNTY HISTORICAL SOCIETY  
FINAL MASTER PLAN  
SHF 24-PL-014  
OCTOBER 9, 2024

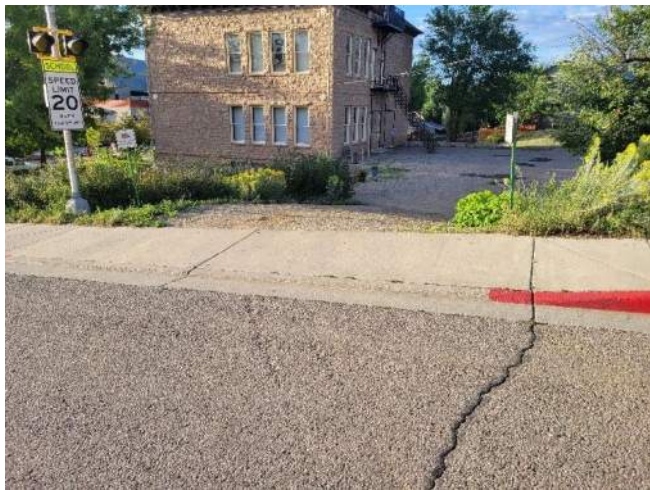
**Access:** Vehicular access to the site presently is located on 31<sup>st</sup> Street at the northwestern property quadrant. The access into the property is a 24-foot driveway curb cut on 31<sup>st</sup> Street and is fairly steep and abrupt as shown in Figure 1 below.

*Figure 1 – Existing 31<sup>st</sup> street driveway access*

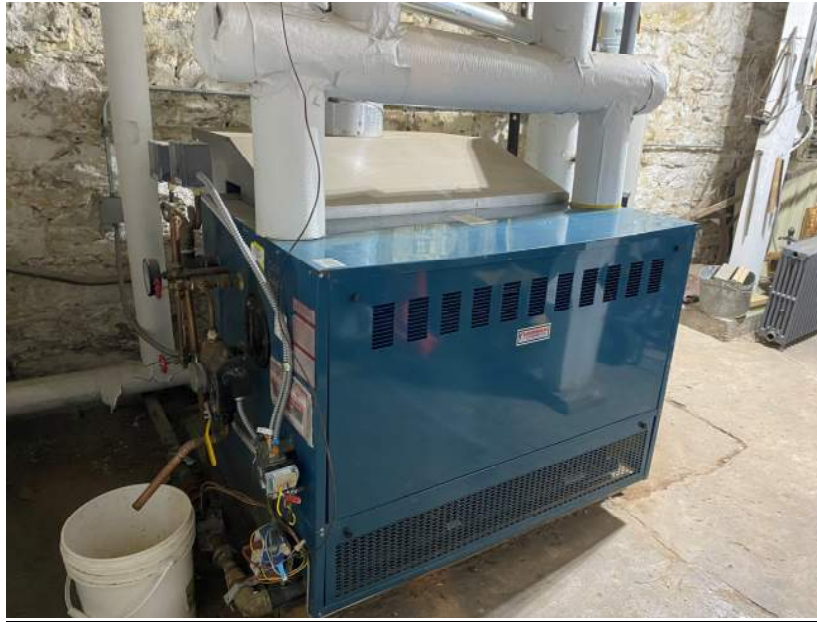
**Existing Boiler in Mechanical Room**

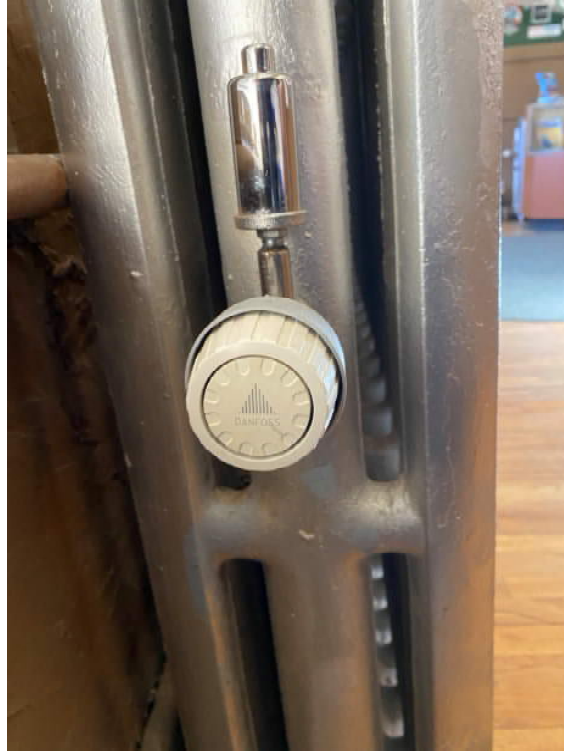
**Typical Danfoss Valve Installed in Radiator Air Aspirator**

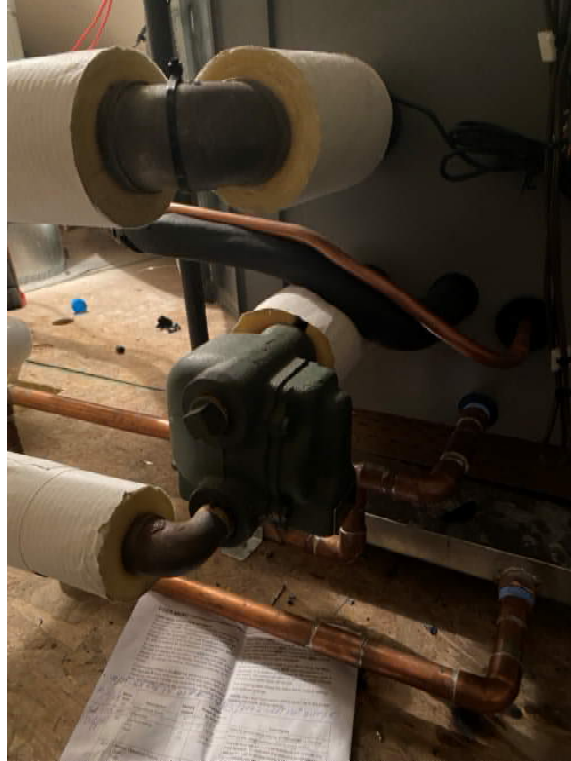
**STEAM Connection to Attic Fan Coil Unit**

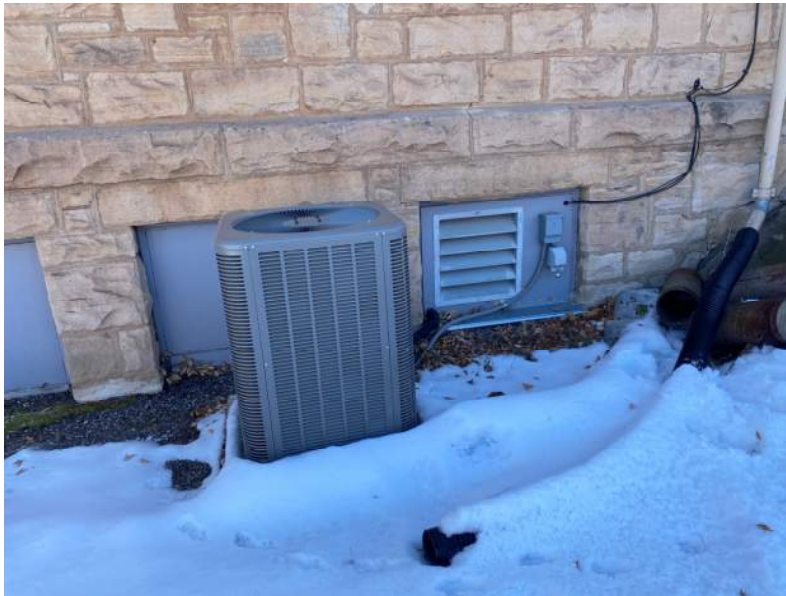
**Condensing Unit for Attic Fan Coil Unit and Combustion Air Louver for Boiler and Water Heater**

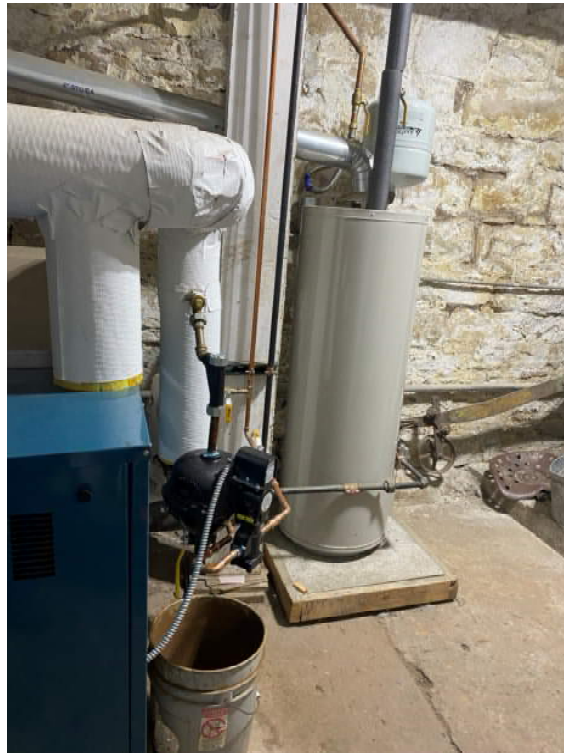
**Existing Water Heater in Mechanical room**

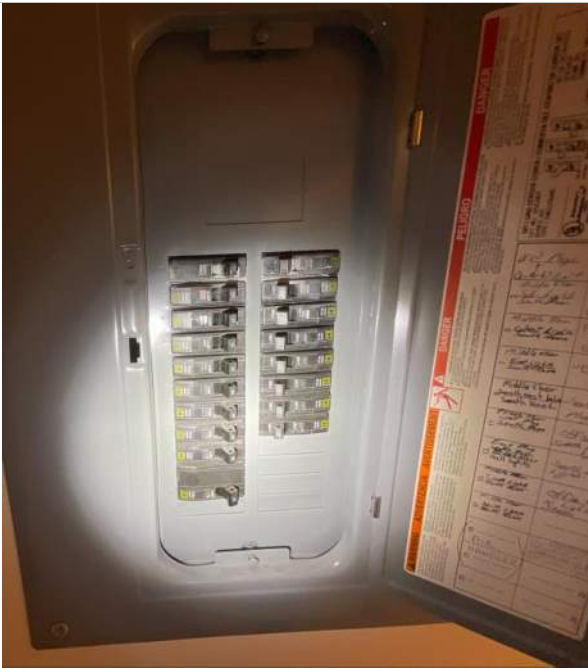
- a. Existing Conditions:
  - i. There are (2) 100A load centers on the interior of the building - one in the basement and one in the attic.
    - 1. Load Center in the basement has 16 poles and is near capacity in terms of breaker space (Photo #3).
    - 2. Load Center in the attic has 24 poles with (5) available spaces (Photo #4).
  - ii. Minimal convenience outlets were observed on interior walls only. Where additional power was needed, extension cords and exposed cabling were in use and observed (Photos #4 and #5).

Photo #4: Load Center - Attic

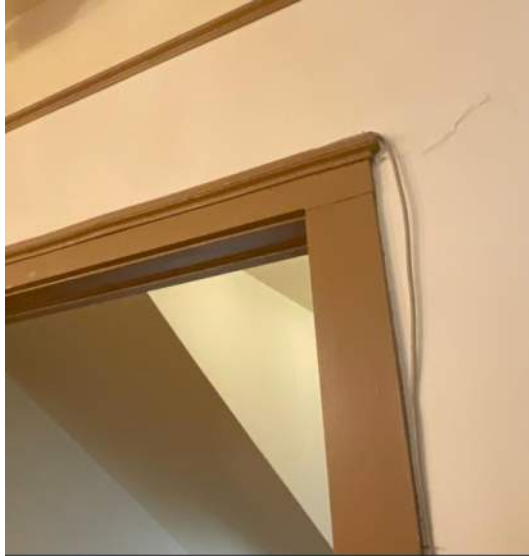
Photo #5: Exposed Cabling around doorway

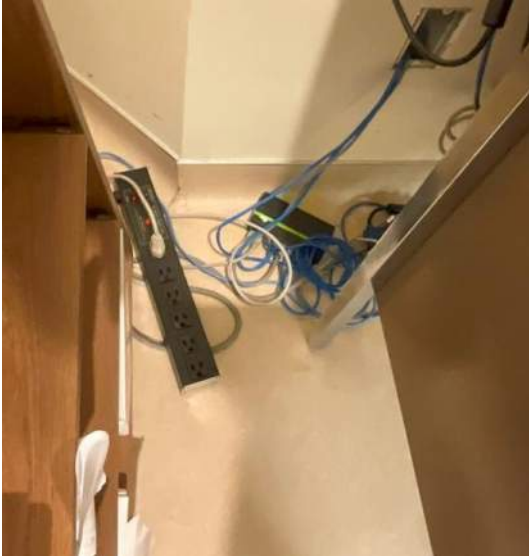
Photo #6: Extension cords in use

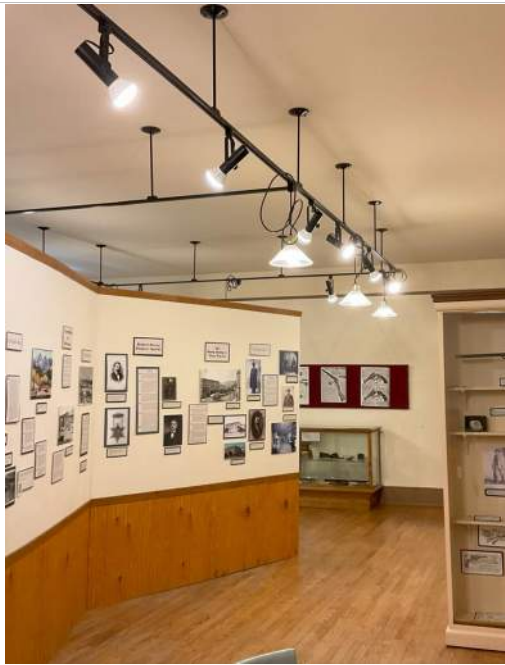
- a. Existing Conditions:
  - i. In the Gallery spaces, a track lighting system was observed. It appears that fixtures have been re-lamped with LED sources (Photo #7).

Photo #7: Track lighting in gallery spaces with LED lamps

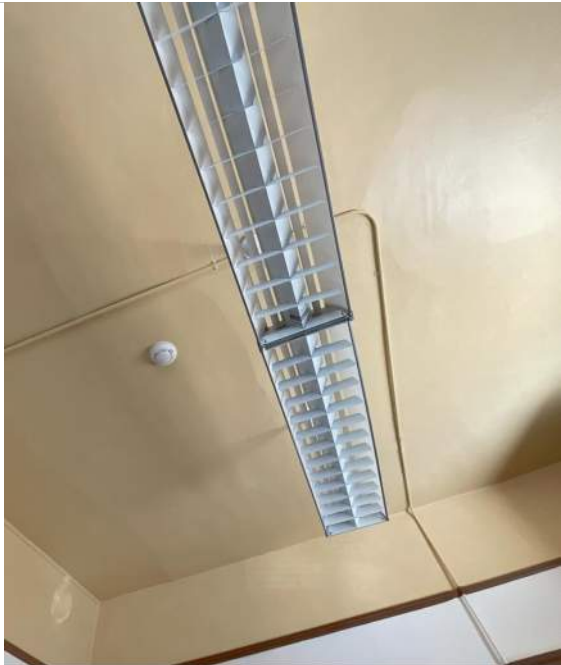
- ii. In other areas, fluorescent fixtures were observed (Photos #8 and #12).
  - iii. Emergency lighting units (frog eyes) and emergency lighting/exit sign combo fixtures were observed throughout the building (Photo #9).

Photo #8: Fluorescent Light fixtures

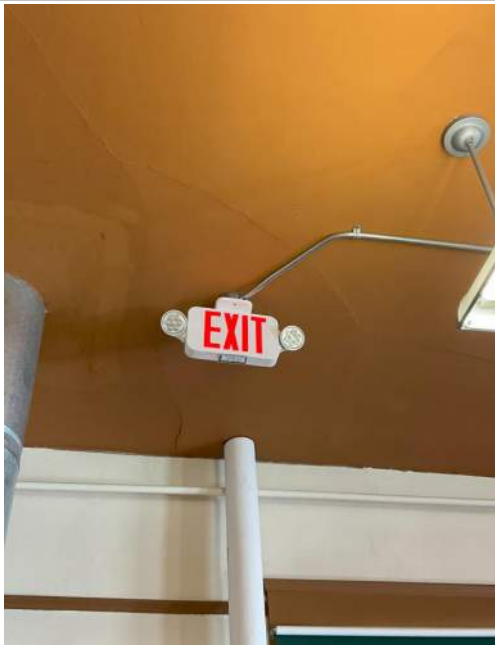
Photo #9: Emergency Lighting/Exit Signs

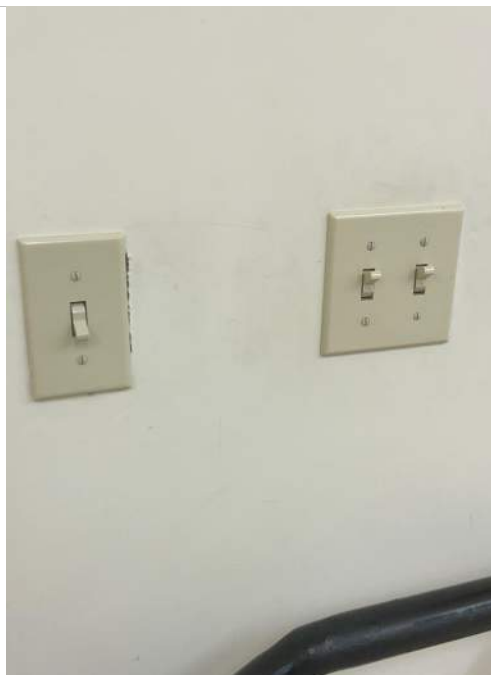
- a. Existing Conditions:
  - i. In Gallery spaces, wall-switch occupancy sensors were observed (Photo #10).
  - ii. In other areas, manual switches were observed (Photo #11).
- b. New Considerations:
  - i. Where lighting fixtures are replaced, update lighting controls to meet energy code requirements which typically consists of replacement of occupancy and/or standard switches with vacancy type switches and potentially the need for additional occupancy sensors to be mounted at the ceiling within most spaces.

Photo #11: Manual line voltage light switches

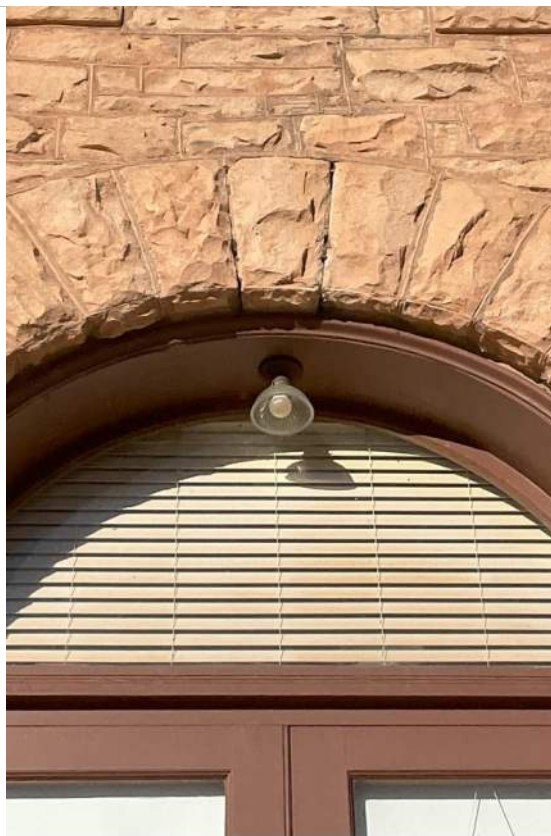
Photo #15: Exterior lighting over door

- 3. Over-door surface-mounted fixtures (Photo #15).
  - v. No existing lighting in the parking lot.
- b. New Considerations:
  - i. In Attic, recommend re-lamping existing fixtures with LED replacement lamps for energy savings.

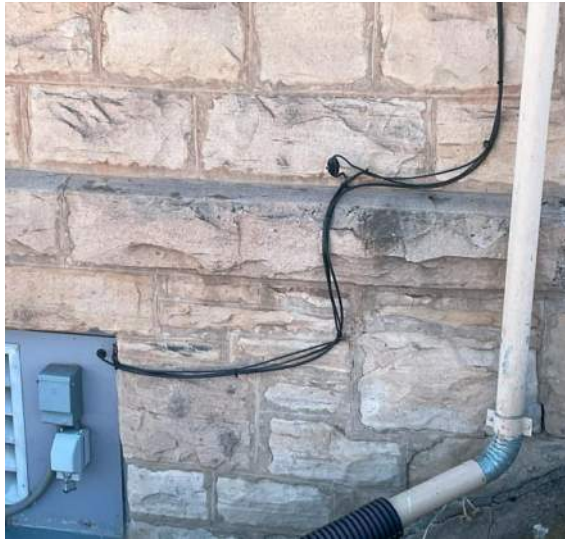
Photo #16: Co-axial cable entering the building

- i. An existing incoming utility service co-axial cable was observed - routed overhead, down the exterior of the building and enters through a wood grill at the southwest corner of the building (Photo #16).
- ii. Co-axial cable runs up through a hole in the floor (Photo #17) to a splitter, near a modem on the first floor (Photo #18).
- iii. From the splitter, there are (2) co-ax cables, each connected to a modem (Photo #18).
- iv. From one modem, it appears there is a connection to the NetworX security cabinet in the basement (Photo #19).
- v. From the other modem, it appears there is a connection to an 8-port network switch in the attic (Photo #20).

- i. Confirm with owner that no additional phone or internet provisions will be required and that the existing infrastructure is adequate. Assuming that it is, following are our recommendations:
  1. Recommend providing fixed mounting for telecom equipment.
  2. Recommend cleaning up loose cables and terminating ethernet cables to wall-mounted faceplates.

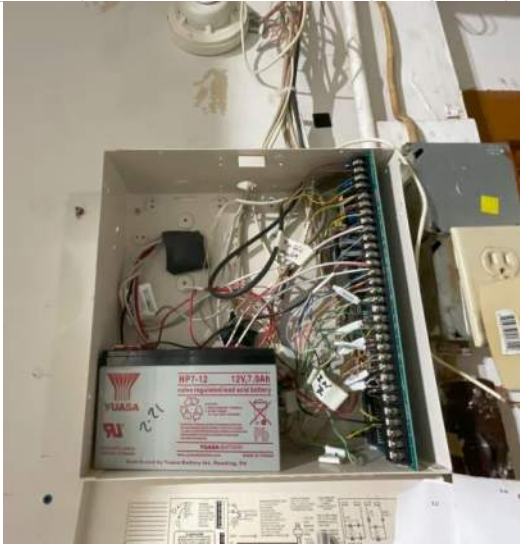
Photo #19: NetworX Security Cabinet in basement

- a. Existing Conditions:
  - i. Motion detectors were observed.
  - ii. The existing security cabinet appears to be near capacity.
- b. New Considerations:
  - i. Discuss with owner. If security system enhancements are desired, system will likely need to be upgraded.
