# *Animas Museum Master Plan*

LA PLATA COUNTY HISTORICAL SOCIETY  
FINAL MASTER PLAN  
SHF 24-PL-014  
OCTOBER 9, 2024

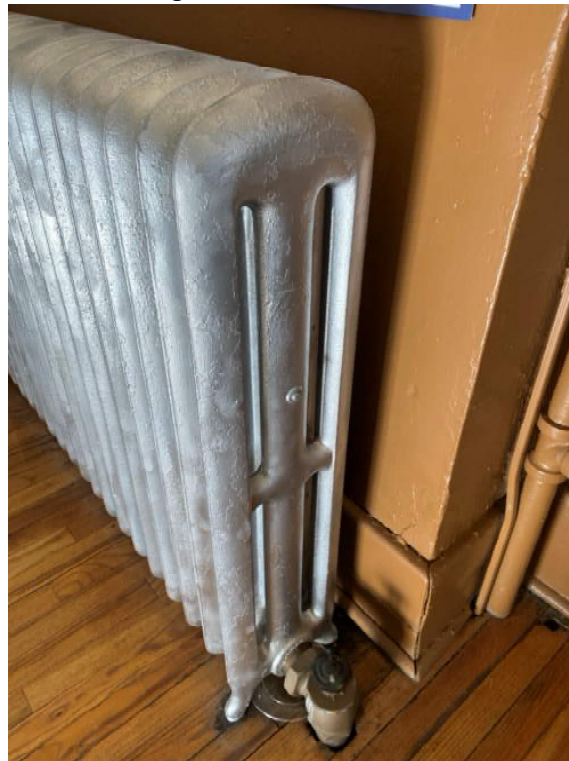
**Typical Radiator and Manual Control Valve**

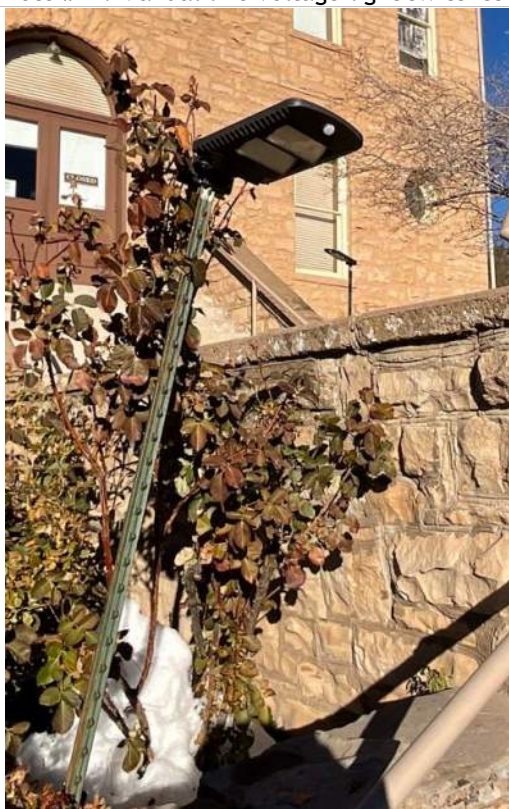
Photo #13: exterior lights

- iv. Existing exterior lighting were observed:
    - 1. Area lights were mounted to studded metal T-post (Photo #13).
    - 2. Solar powered path lights (Photo #14).
